Final Report

Department of Community Affairs  
DCA Contract 03-RC-11-14-00-22-034

# Loss Relativities for FBC Wood Panel Shutters

The purpose of this project is to develop loss relativities for 1 and 2 family residential structures that have openings protected by wood structural panels, as allowed by the Florida Building Code (FBC).

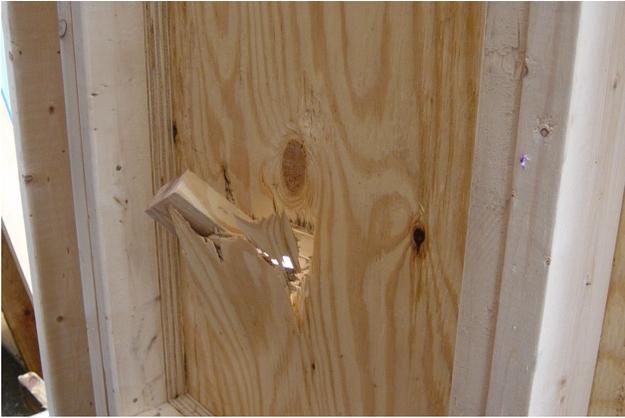
**Figure 2-1. Typical 4.5 lb. 2x4 Missile Impact on Plywood Panel**

Figures 2-1 through 2-4 illustrate typical 2x4 and clay tile missile impacts on the plywood and OSB specimen.

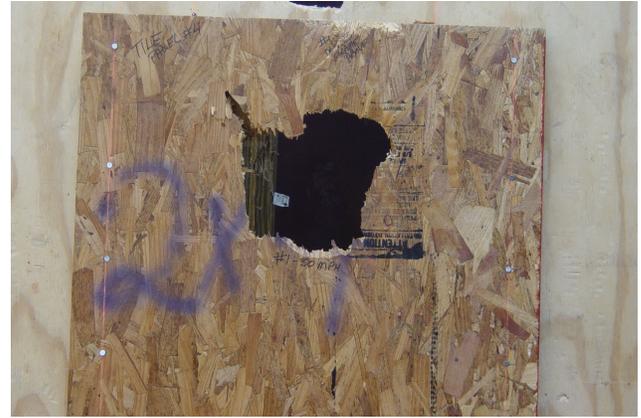
**Figure 2-4. Typical 6.6 lb. Clay Tile Impact on OSB Panel**

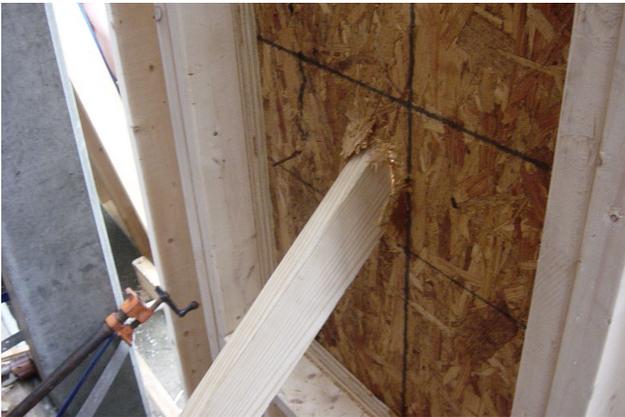
**Figure 2-2. Typical 4.5 lb. 2x4 Missile Impact on OSB Panel.**

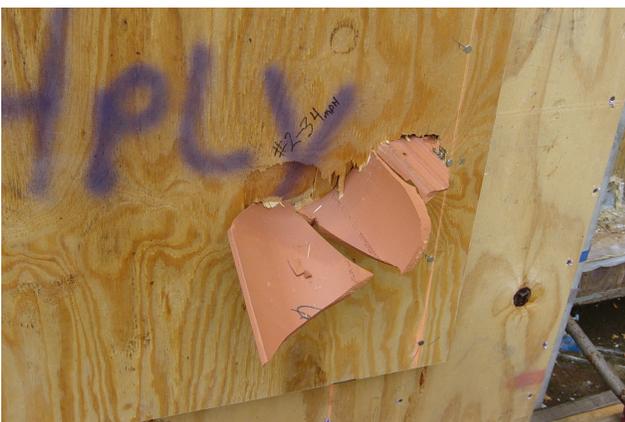
**Figure 2-3. Typical 6.6 lb. Clay Tile Impact on Plywood Panel**

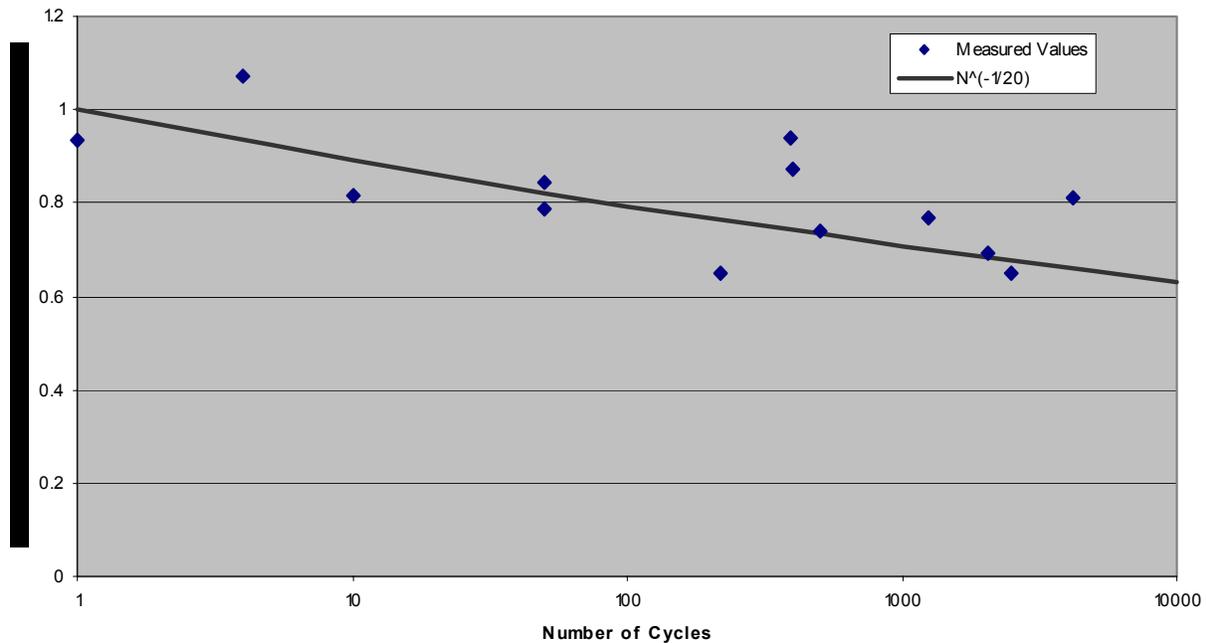
Fatigue Data for Nailed Shutters

**Figure 2-5. Reduction in Capacity as a Function of the Number of Loading Cycles and Load Level**

towards a reduction in capacity as the number of cycles increases. An equation has been superimposed on the graph using the type of formula employed to describe the reduction in allowable stress as a function of the number of cycles for metals. It appears that as long as the load level is maintained at a level below about 60 percent of the expected ultimate capacity, that the panel attachment can sustain a large number of constant amplitude cycles. More work needs to be done to refine the curve and to determine whether a procedure such as Minor's rule for accumulation of damage can be used to combine effects from varying amplitudes of loading.

An initial test was conducted by subjecting a shutter panel to a monotonically increasing quasi-static pressure until failure occurred. The 1<sup>st</sup> panel was removed and a second panel was installed using the same nailing schedule but with the nails carefully shifted so that each new nail hit a different location on the frame than the original nails. Constant amplitude cyclic pressures ranging from 0.3P to P were applied where P was a pressure lower than the original single cycle failure pressure. This process was repeated for each frame by constantly shifting the nailing locations and reducing the pressure P until it was possible to apply several thousand cycles of the chosen pressure without failing the attachment of the panel. Information obtained from these tests is included in Appendix C. The results have been normalized by the initial single cycle static failure pressure and plotted against the number of cycles to failure in Figure 2-5.

Note that there is considerable scatter in the results and, in one case; a panel was actually successfully tested to 4 cycles at a higher pressure than the original static failure pressure. Nevertheless, the trend is certainly

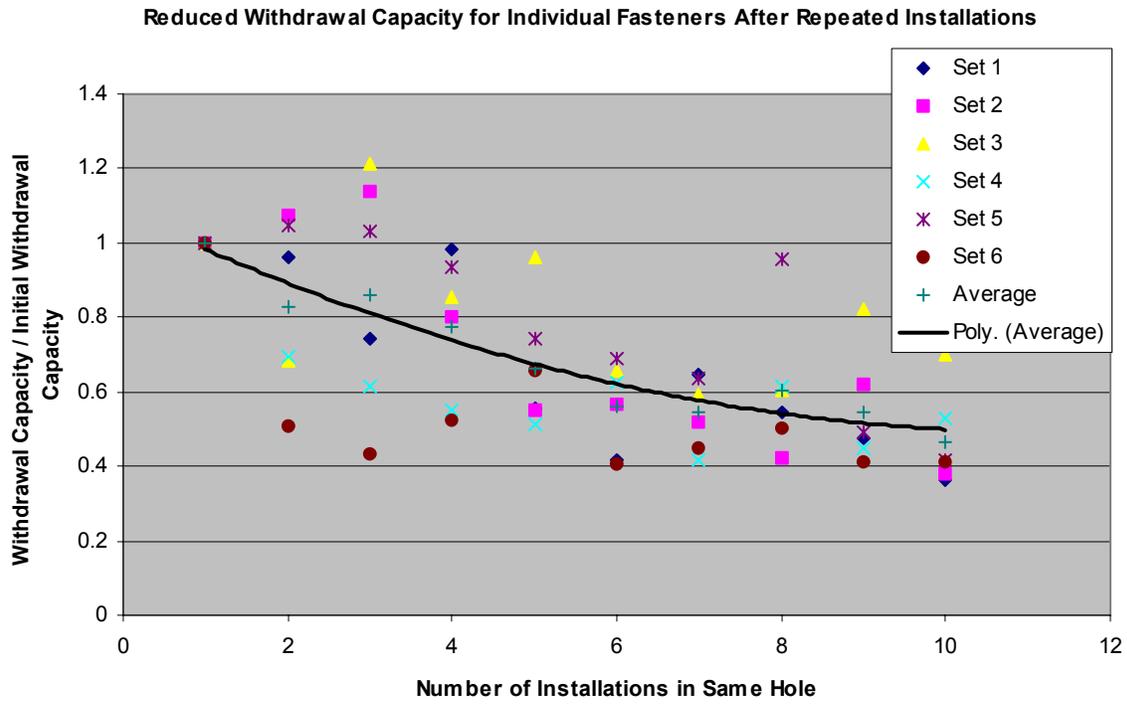
**Figure 2-6. Variation in Wood Frame Withdrawal Capacity for Repeated Installation of Fasteners**

measure the force required to remove the nail. A new nail was then re-installed in the same hole with the nail driven to the same depth and the force required to withdraw the new nail was measured. This was repeated ten times in the same hole before the process was started again. Results of these tests are reported in Appendix C and plotted in Figure 2-6.

Again, there is considerable scatter in the results from the repeated tests with some subsequent applications yielding higher withdrawal capacities than the initial installation. This may be due to slight differences in the nail diameters of an additional reflection of the large variability in measurements involving natural wood products. A trend line based on the average capacities obtained from the six sets of tests suggests that there is a general reduction in withdrawal capacity with repeated installation in the same hole and that the reduction may reach 50 percent after 10 repeated installations in the same hole.

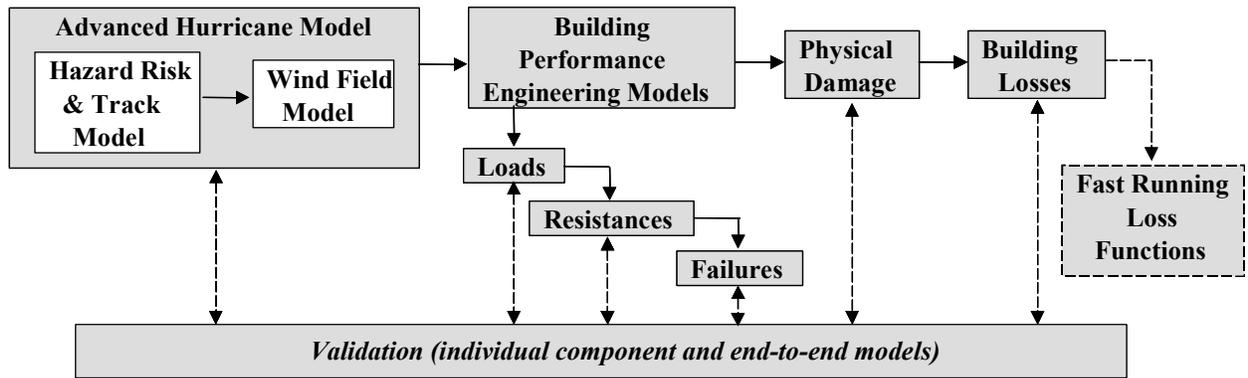
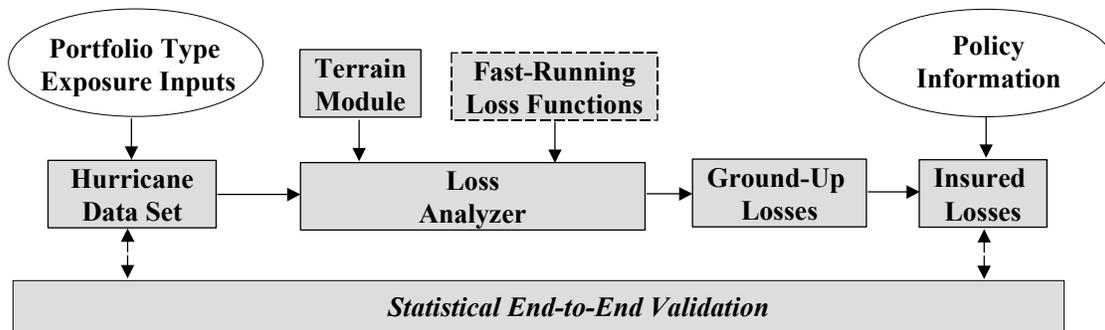
**(a) Individual Buildings and Building Class Performance Model**

**(b) Multiple Site – Multiple Building Loss Projections**

**Figure 3-1. HURLOSS Modeling Approach for Hurricane Loss Projections**

The HURLOSS model is used to compute ground-up losses and insured losses in this study. The HURLOSS modeling approach is illustrated in Figure 3-1, which is taken from ARA's submittal to the FCHLPM. The individual building model approach shown in Figure 3-1a has been used in this study.

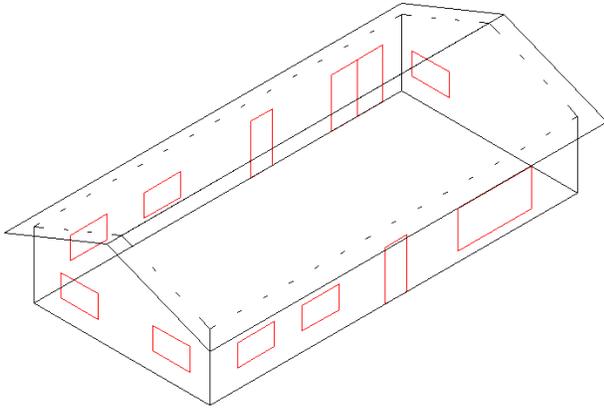
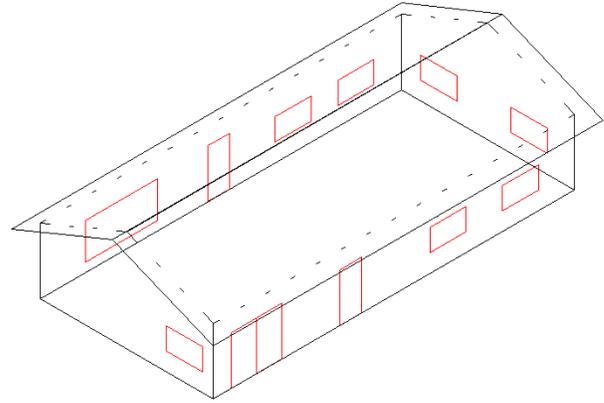
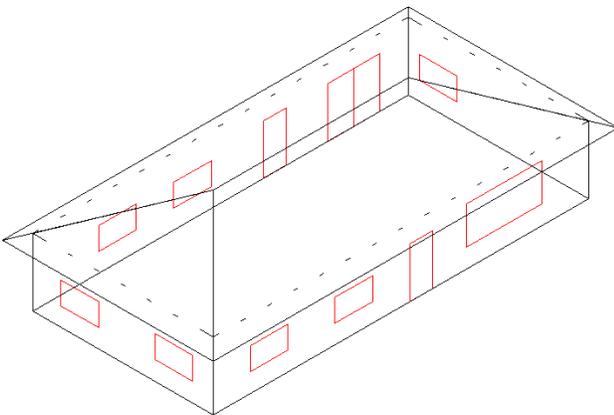
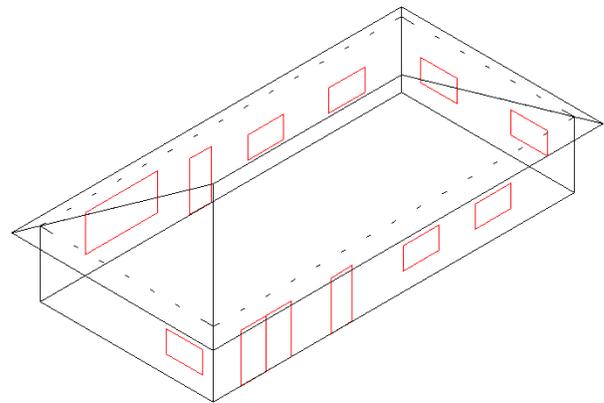
**a. Front Isometric View – 0011G**

**b. Back Isometric View – 0011G**

**c. Front Isometric View – 0011H**

**d. Back Isometric View – 0011H**

**Figure 3-2. Model House 0011 – Gable and Hip**

The houses are modeled with the geometrical layouts as given in Figures 3-2, 3-3, and 3-4. Hence, the specific window, door, etc. locations shown in these figures are used in the computation of loads and failures for each individual component.

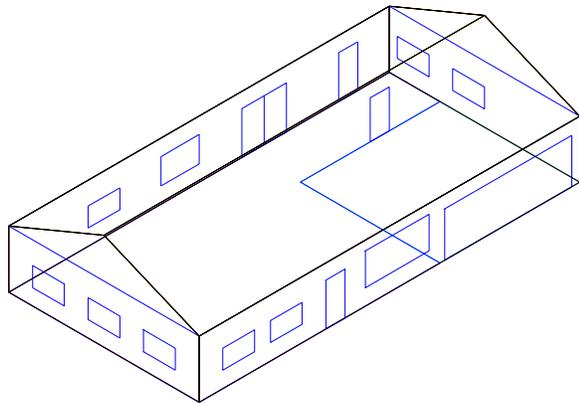
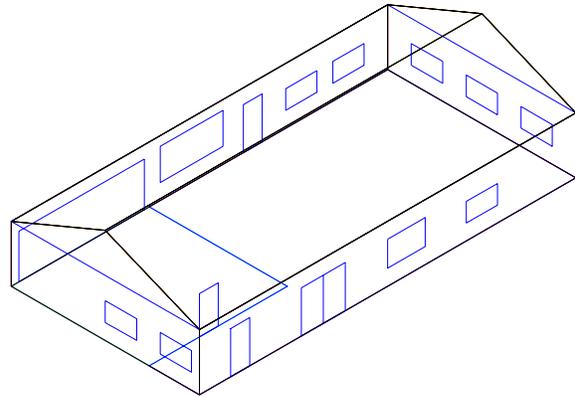
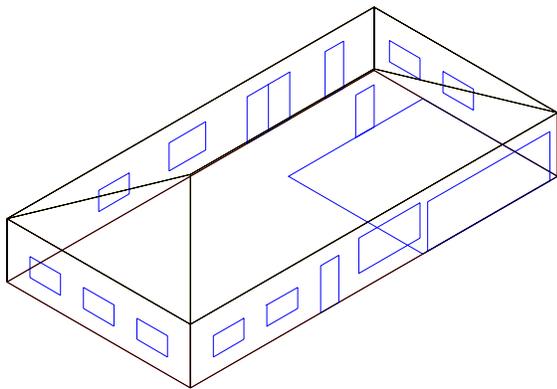
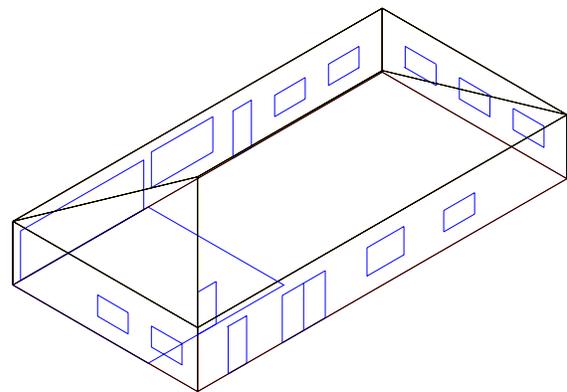
**a. Front Isometric View – 0013G**

**b. Back Isometric View – 0013G**

**c. Front Isometric View – 0013H**

**d. Back Isometric View – 0013H**

**Figure 3-3. Model House 0013 – Gable and Hip**

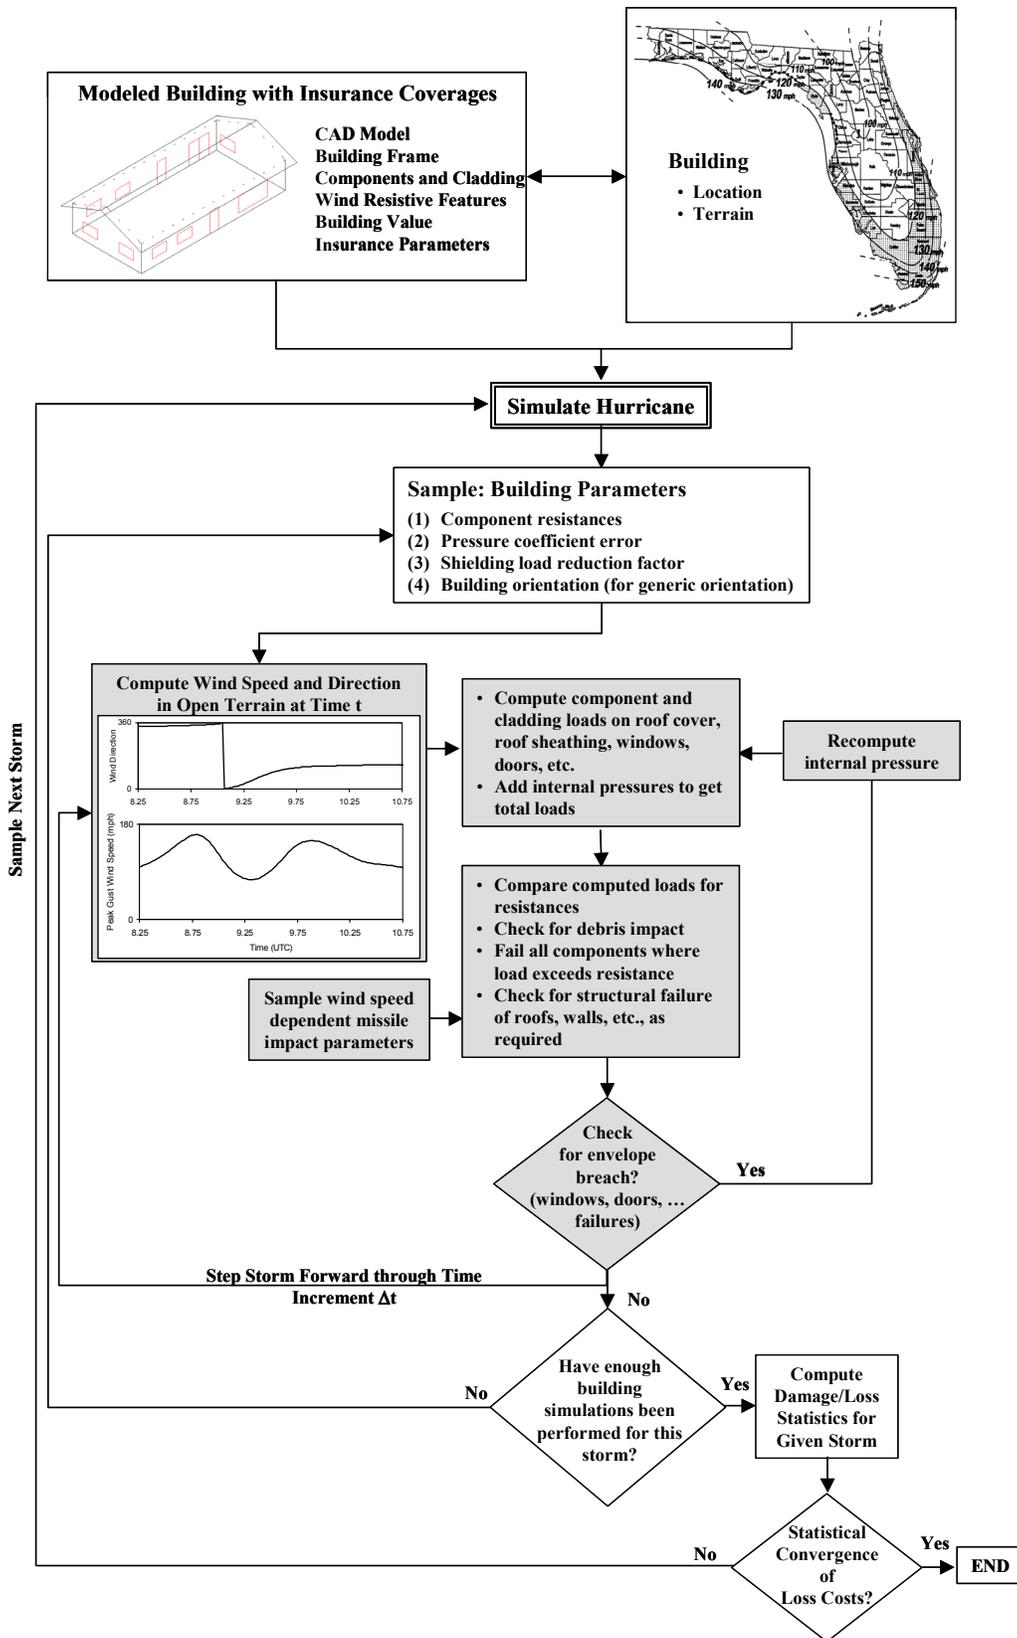
**Figure 3-4. HURLOSS Building Damage Simulation Methodology**

The progressive failure damage modeling approach is summarized in Figure 3-4. Estimates of wind loads as a function of wind direction are produced for building components, including roof cover, roof

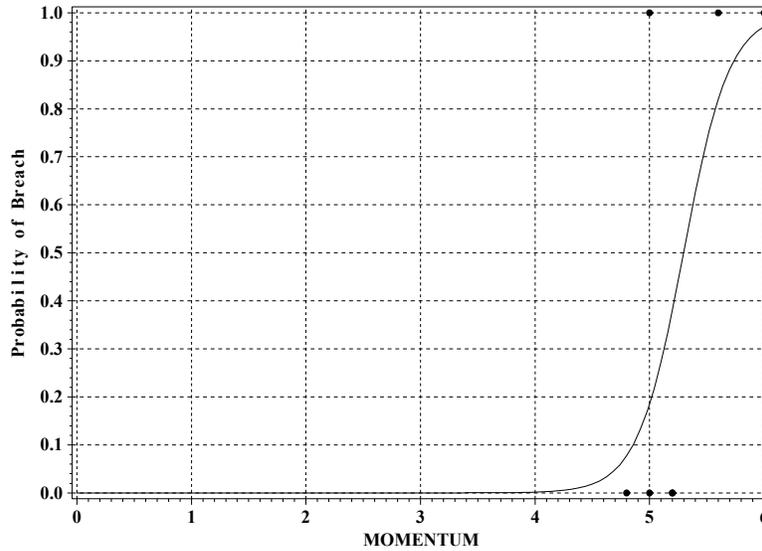
Material = OSB Opening = Large Missile = 2x4 Location = Central

```
----- MATERIAL=OSB OPENING=Large MISSILE=2x4 LOCATION=Central
              Analysis of Maximum Likelihood Estimates
Variable DF   Parameter Standard      Wald      Pr >      Standardized
          Estimate  Error  Chi-Square Chi-Square Estimate
INTERCPT 1   -26.4708  20.3911    1.6852    0.1942    .
MOMENTUM 1     4.9974   3.9220    1.6236    0.2026    1.134410
```

**Figure 3-5. Momentum Logistic Model for OSB, 2x4 Missile, Central Impacts**

We extracted the data from Appendix A and analyzed it in various ways to develop wood panel perforation models. Some examples of the resulting logistic fits of the data for the 2x4 wood plank missile on large openings are given in Figure 3-5 through 3-8. The dots on the figures are the individual test results. Those tests with no breach of the panel (i.e., the missile bounced off the panel and did not stick in the panel or punch all the way through the panel) are plotted at the 0 probability position. Those tests that perforated the panel are plotted at the 1 probability position.

As noted in Section 2, the breach threshold for edge impacts occurs at lower velocities than the breach threshold for central impacts. Central impacts cause the panel to flex in bending, whereas edge impacts are a simple punch through shear failure. The differences in plywood and OSB can be seen in these figures, as larger momenta (impact speeds) are required for plywood failures.

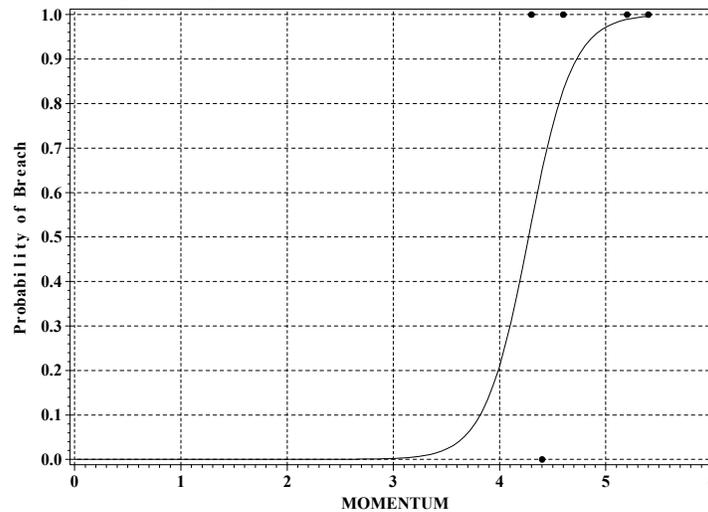
Material = OSB Opening = Large Missile = 2x4 Location = Edge

```
----- MATERIAL=OSB OPENING=Large MISSILE=2x4 LOCATION=Edge
              Analysis of Maximum Likelihood Estimates
Variable DF   Parameter Standard      Wald      Pr >      Standardized
          Estimate  Error  Chi-Square Chi-Square Estimate
INTERCPT 1   -20.7693  32.3699    0.4117    0.5211    .
MOMENTUM 1     4.8614   7.3093    0.4423    0.5060    1.318489
```

**Figure 3-6. Momentum Logistic Model for OSB, 2x4 Missile, Edge Impacts**

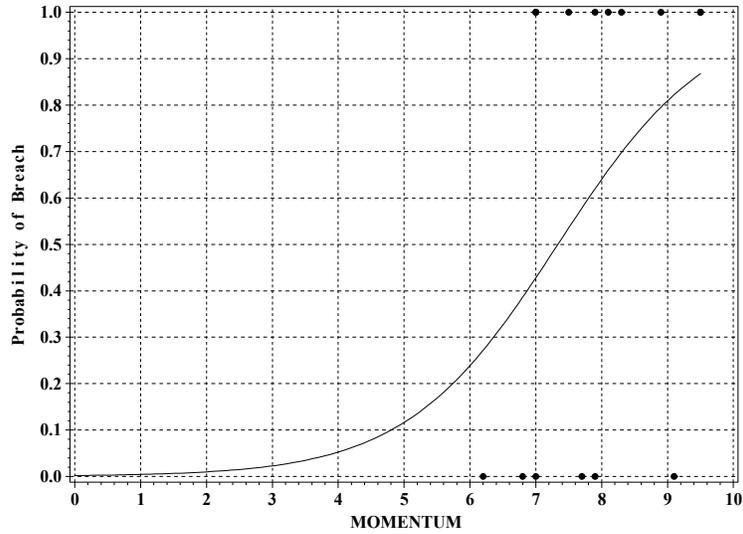
Material = Plywood Opening = Small Missile = 2x4 Location = Central

----- MATERIAL=Plywood OPENING=Large MISSILE=2x4 LOCATION=Central  
 Analysis of Maximum Likelihood Estimates

Variable	DF	Parameter Estimate	Standard Error	Wald Chi-Square	Pr > Chi-Square	Standardized Estimate
INTERCPT	1	-6.3722	5.0102	1.6176	0.2034	.
MOMENTUM	1	0.8684	0.6451	1.8122	0.1782	0.487076

**Figure 3-7. Momentum Logistic Model for Plywood, 2x4 Missile, Central Impacts**

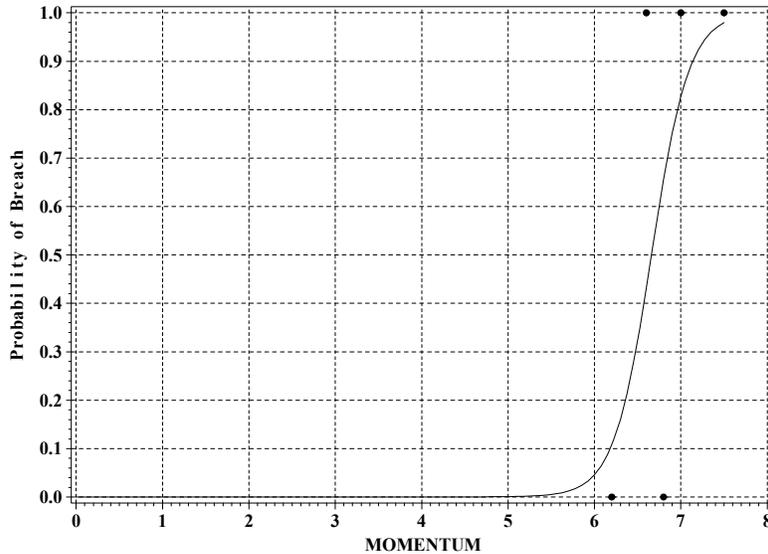
Material = Plywood Opening = Small Missile = 2x4 Location = Edge

----- MATERIAL=Plywood OPENING=Large MISSILE=2x4 LOCATION=Edge  
 Analysis of Maximum Likelihood Estimates

Variable	DF	Parameter Estimate	Standard Error	Wald Chi-Square	Pr > Chi-Square	Standardized Estimate
INTERCPT	1	-30.6041	28.7864	1.1303	0.2877	.
MOMENTUM	1	4.5950	4.2849	1.1500	0.2835	1.220238

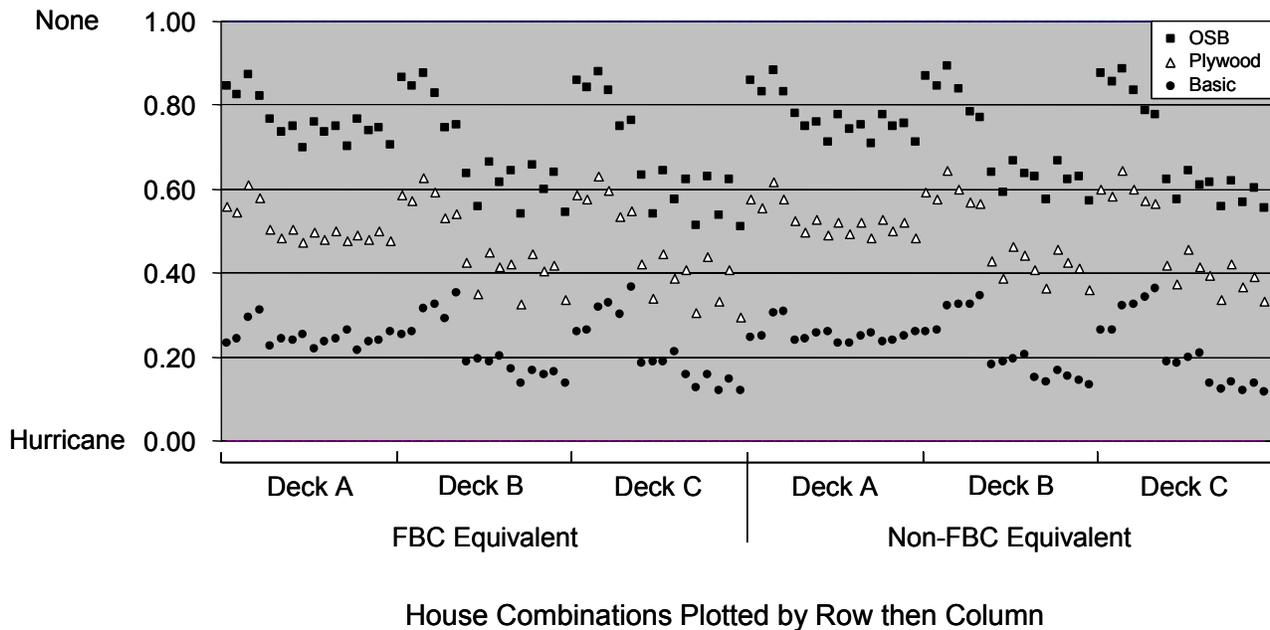
**Figure 3-9. Terrain B Loss Relativities (Normalized Within Cell Group) Ranging from None (1.0) to Hurricane (0.0)**

One of the simplifications we examined was to see if additional levels of shutters could be implemented as a separate constant factor adjustment to the Basic or Hurricane level that is already built into the tables. To determine if this simplification is possible, we produced the plots in Figures 3-9 and 3-10. These plots show normalized-within-cell-group relativities of the effect of opening protection, ranging from Hurricane (plotted at 0) and None (plotted at 1). We see that Basic Protection (175 ft-lb of energy impact resistance), Plywood, and OSB

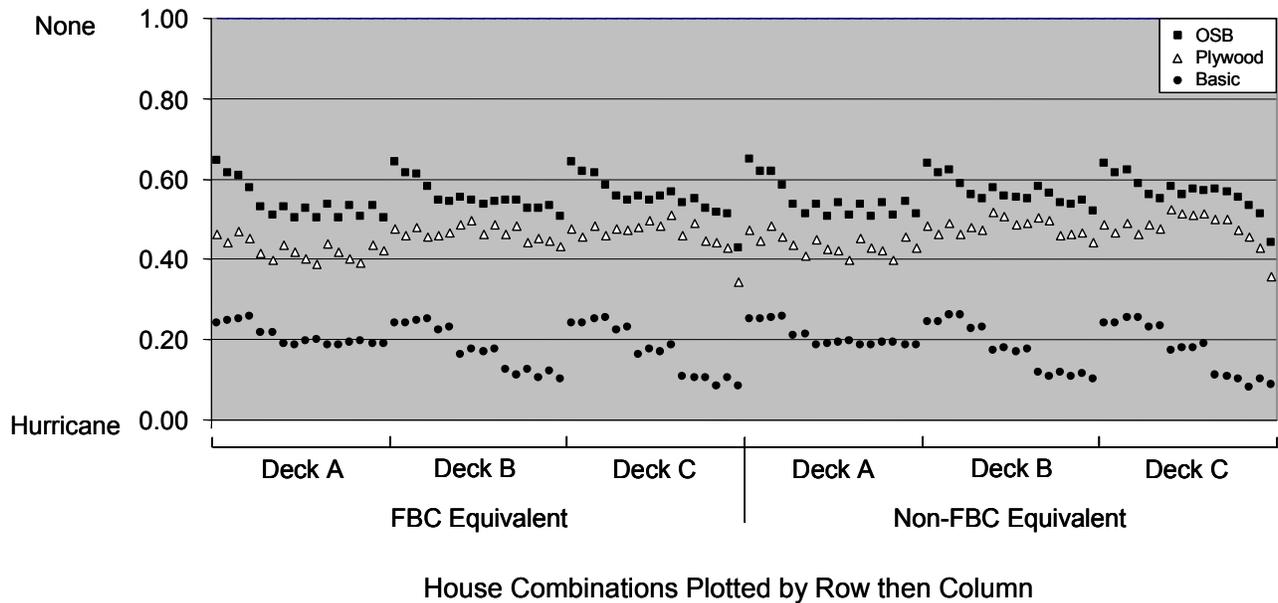
**Figure 3-10. Terrain C Loss Relativities (Normalized Within Cell Group) Ranging from None (1.0) to Hurricane (0.0)**

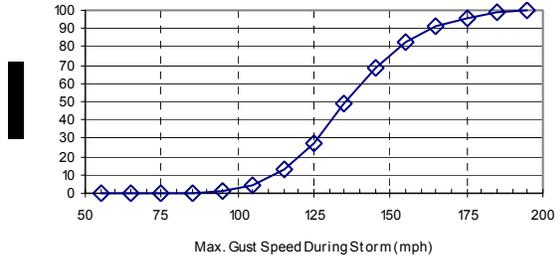
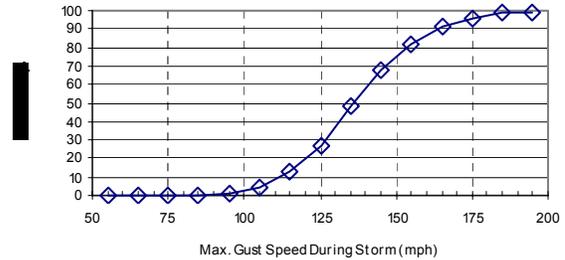
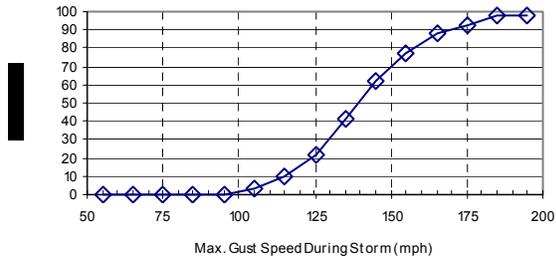
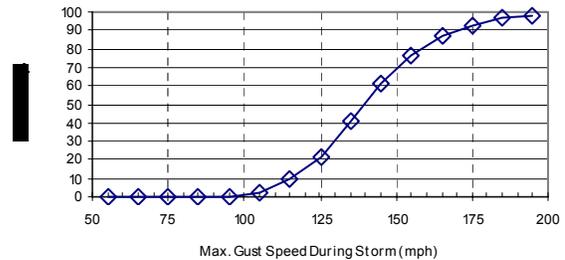
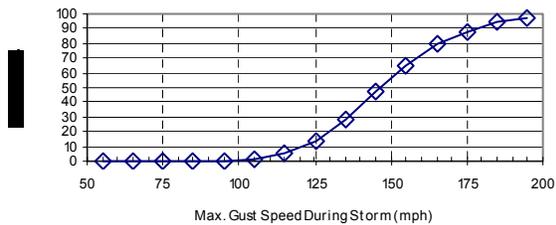
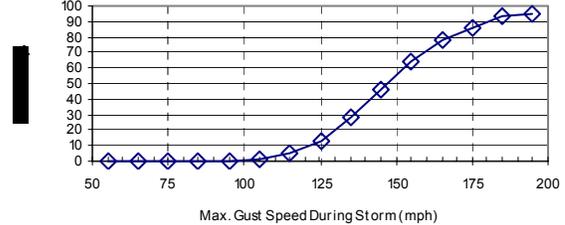
**Percent of Storms Producing Failed Fenestrations - No Opening Protection**

**Percent of Storms Producing Failed Fenestrations - OSB Opening Protection**

**Percent of Storms Producing Failed Fenestrations - Plywood Opening Protection**

**Figure 3-11. Comparison of HURLOSS Estimated Failure Rates for Various Levels of Opening Protection for Miami Location**

Similar to the plots of component damage in Reference 1, we have produced plots of openings failures for the five levels of protection (None, OSB, plywood, Basic, and Hurricane) shown in the previous tables. Figure 3-11 shows the percentage of storms that produce failures for two houses. The “weak” house is the upper-left most entry in the tables and the “strong” house is the lower-right most entry in the tables. The effect of different levels of protection can be easily seen as you look down the page. For example, for 150 mph peak gust winds, the percent of storms that produce at least one failed fenestration is 65%, 58%, 44%, 23%, and 9%, for None, OSB, Plywood, Basic, and Hurricane, respectively.

At lower windspeeds, the effect of some opening protection is more pronounced, particularly for plywood, which reduces the failure rate over no protection by about 50%.

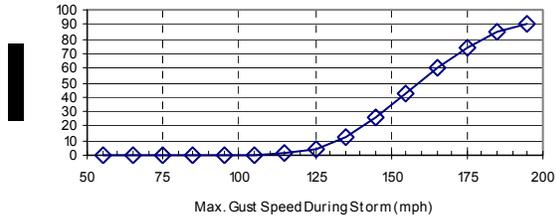
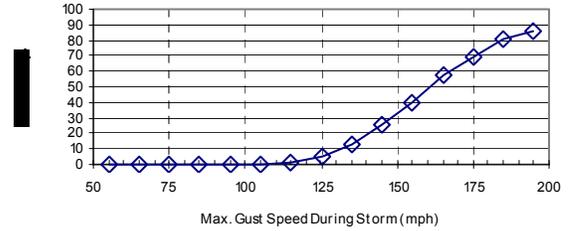
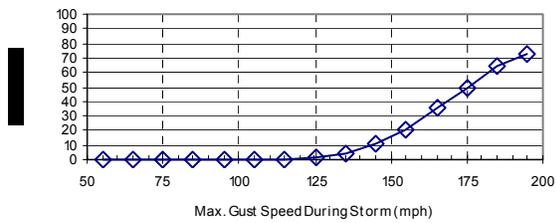
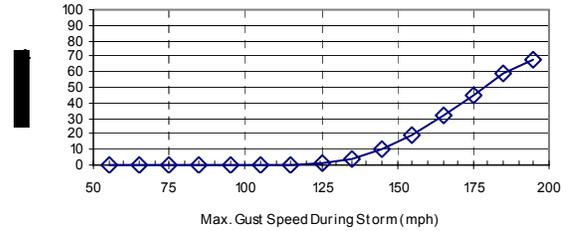
**Percent of Storms Producing Failed Fenestrations - Basic Opening Protection**

**Percent of Storms Producing Failed Fenestrations - Hurricane Opening Protection**

**Figure 3-11. Comparison of HURLOSS Estimated Failure Rates for Various Levels of Opening Protection for Miami Location (concluded)**

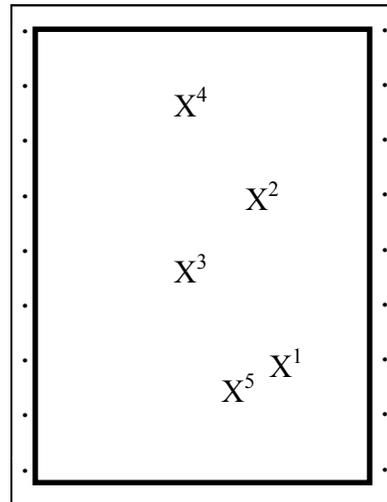
X# - Missile strike location

## ARA / DCA Impact Tests for Code Minimum Shutters

<b>Test Number:</b> Panel 2			
<b>Panel Type:</b> 15/32 Plywood 3-ply			
<b>Panel Layout:</b> 2' x 4' Opening Strong Axis in 4' direction	<b>Nailing Schedule and Location:</b> 12d common 6" along sides of the panel		
<b>Missile Impact:</b> <input type="checkbox"/> None <input checked="" type="checkbox"/> 2x4 <input type="checkbox"/> Clay Tile	<b>Pressure Test:</b> <input type="checkbox"/> None <input type="checkbox"/> Monotonic to Failure ___ psf failure <input type="checkbox"/> Cyclic _____ Design Wind Speed <input type="checkbox"/> _____ Number of Cycles to Failure		
<b>Results of Missile Tests:</b>			
<b>Impact #</b>	<b>Missile Weight</b>	<b>Missile Speed</b>	<b>Damage Observation</b>
1	4.54 lb	30 mph	2/3 from top – Indentation – no puncture
2	4.54 lb	35 mph	Center – Punctured shutter
3	4.54 lb	32 mph	Upper RHS Corner – Punctured Shutter
4	4.54 lb	29 mph	Missed shutter – hit below shutter
5	4.54 lb	NS	Punched through plywood

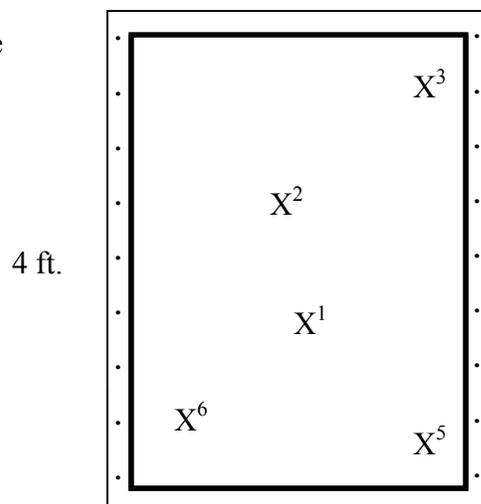
X<sup>#</sup> - Missile strike location

## ARA / DCA Impact Tests for Code Minimum Shutters

<b>Test Number:</b> Panel 3			
<b>Panel Type:</b> 15/32 Plywood 4-ply			
<b>Panel Layout:</b> 2' x 4' Opening Strong Axis in 4' direction	<b>Nailing Schedule and Location:</b> 12d common 6" along sides of the panel		
<b>Missile Impact:</b> <input type="checkbox"/> None <input checked="" type="checkbox"/> 2x4 <input type="checkbox"/> Clay Tile	<b>Pressure Test:</b> <input type="checkbox"/> None <input type="checkbox"/> Monotonic to Failure ___ psf failure <input type="checkbox"/> Cyclic _____ Design Wind Speed <input type="checkbox"/> _____ Number of Cycles to Failure		
<b>Results of Missile Tests:</b>			
<b>Impact #</b>	<b>Missile Weight</b>	<b>Missile Speed</b>	<b>Damage Observation</b>
1	4.54 lb	32 mph	Partial shear of panel along one edge of impact – cracking and splitting of back
2	4.54 lb	34 mph	Center of panel - no penetration but more damage to panel
3	4.54 lb	35 mph	Upper RH Corner - Punctured Shutter

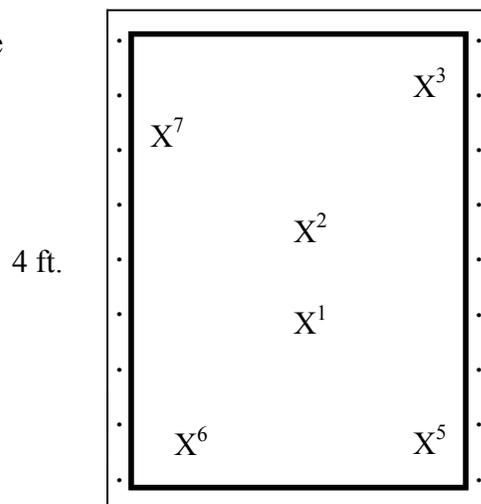
X<sup>#</sup> - Missile strike location

## ARA / DCA Impact Tests for Code Minimum Shutters

<b>Test Number:</b> Panel 4			
<b>Panel Type:</b> 15/32 Plywood 4-ply			
<b>Panel Layout:</b> 2' x 4' Opening Strong Axis in 4' direction	<b>Nailing Schedule and Location:</b> 12d common 6" along sides of the panel		
<b>Missile Impact:</b> <input type="checkbox"/> None <input checked="" type="checkbox"/> 2x4 <input type="checkbox"/> Clay Tile	<b>Pressure Test:</b> <input type="checkbox"/> None <input type="checkbox"/> Monotonic to Failure ___ psf failure <input type="checkbox"/> Cyclic _____ Design Wind Speed <input type="checkbox"/> _____ Number of Cycles to Failure		
<b>Results of Missile Tests:</b>			
<b>Impact #</b>	<b>Missile Weight</b>	<b>Missile Speed</b>	<b>Damage Observation</b>
1	4.54 lb	34 mph	Center - no penetration – slight indentation
2	4.54 lb	35 mph	Center (low) – indented panel - no penetration
3	4.54 lb	38 mph	Center - penetration
4	4.54 lb	37 mph	Middle Right – indented panel - no penetration

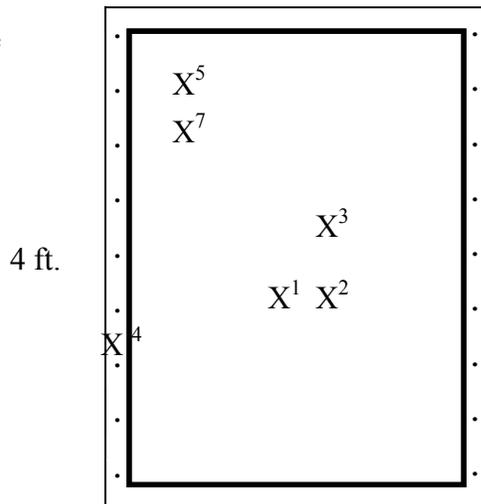
<b>Test Number:</b> Panel 5			
<b>Panel Type:</b> 7/16 Oriented Strand Board			
<b>Panel Layout:</b> 2' x 4' Opening Strong Axis in 4' direction	<b>Nailing Schedule and Location:</b> 12d common 6" along sides of the panel		
<b>Missile Impact:</b> <input type="checkbox"/> None <input checked="" type="checkbox"/> 2x4 <input type="checkbox"/> Clay Tile	<b>Pressure Test:</b> <input type="checkbox"/> None <input type="checkbox"/> Monotonic to Failure ___ psf failure <input type="checkbox"/> Cyclic _____ Design Wind Speed <input type="checkbox"/> _____ Number of Cycles to Failure		
<b>Results of Missile Tests:</b>			
<b>Impact #</b>	<b>Missile Weight</b>	<b>Missile Speed</b>	<b>Damage Observation</b>
1	4.54 lb	29 mph	Center - penetration
2	4.54 lb	26 mph	Center - penetration
3	4.54 lb	24 mph	Center Right - penetration
4	4.54 lb	NS	Missed Left
5	4.54 lb	24 mph	Upper Left - penetration
6	4.54 lb	23 mph	Upper Left - no penetration

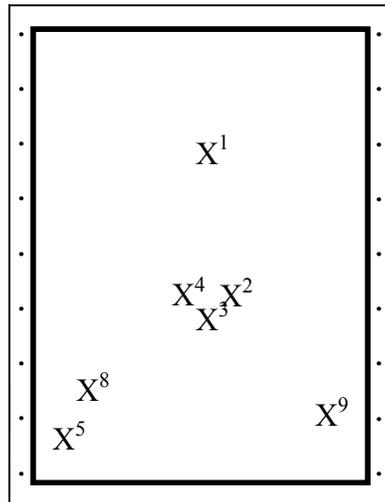
<b>Test Number:</b> Panel 6			
<b>Panel Type:</b> 7/16 Oriented Strand Board			
<b>Panel Layout:</b> 2' x 4' Opening Strong Axis in 4' direction	<b>Nailing Schedule and Location:</b> 12d common 6" along sides of the panel		
<b>Missile Impact:</b> <input type="checkbox"/> None <input checked="" type="checkbox"/> 2x4 <input type="checkbox"/> Clay Tile	<b>Pressure Test:</b> <input type="checkbox"/> None <input type="checkbox"/> Monotonic to Failure ___ psf failure <input type="checkbox"/> Cyclic _____ Design Wind Speed <input type="checkbox"/> _____ Number of Cycles to Failure		
<b>Results of Missile Tests:</b>			
<b>Impact #</b>	<b>Missile Weight</b>	<b>Missile Speed</b>	<b>Damage Observation</b>
1	4.54 lb	25 mph	Upper Middle - penetration
2	4.54 lb	21 mph	Center - penetration
3	4.54 lb	21 mph	Center - penetration
4	4.54 lb	21 mph	Middle Left - penetration
5	4.54 lb	NS	Lower Left - penetration
6	4.54 lb	19 mph	Missed Low

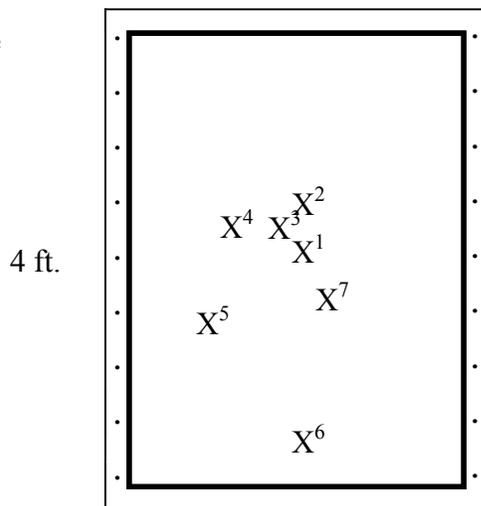
<b>Test Number:</b> Panel 7			
<b>Panel Type:</b> 15/32 Plywood – 3 ply soaked for 24 hrs in water bath			
<b>Panel Layout:</b> 2' x 4' Opening Strong Axis in 4' direction	<b>Nailing Schedule and Location:</b> 12d common 6" along sides of the panel		
<b>Missile Impact:</b> <input type="checkbox"/> None <input checked="" type="checkbox"/> 2x4 <input type="checkbox"/> Clay Tile	<b>Pressure Test:</b> <input type="checkbox"/> None <input checked="" type="checkbox"/> Monotonic to Failure <u>205</u> psf failure <input type="checkbox"/> Cyclic _____ Design Wind Speed <input type="checkbox"/> _____ Number of Cycles to Failure		
<b>Results of Missile Tests:</b>			
<b>Impact #</b>	<b>Missile Weight</b>	<b>Missile Speed</b>	<b>Damage Observation</b>
1	4.54 lb	34 mph	Center - no penetration and no cracking – Nails across from impact starting to back out
2	4.54 lb	37 mph	No penetration
3	4.54 lb	40 mph	No penetration

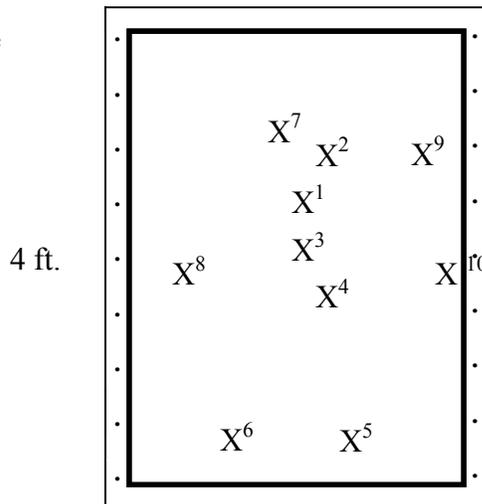
<b>Test Number:</b> Panel 8			
<b>Panel Type:</b> 15/32 Plywood – 4 ply soaked for 24 hrs in water bath			
<b>Panel Layout:</b> 2' x 4' Opening Strong Axis in 4' direction	<b>Nailing Schedule and Location:</b> 12d common 6" along sides of the panel		
<b>Missile Impact:</b> <input type="checkbox"/> None <input checked="" type="checkbox"/> 2x4 <input type="checkbox"/> Clay Tile	<b>Pressure Test:</b> <input type="checkbox"/> None <input type="checkbox"/> Monotonic to Failure ___ psf failure <input type="checkbox"/> Cyclic _____ Design Wind Speed <input type="checkbox"/> _____ Number of Cycles to Failure		
<b>Results of Missile Tests:</b>			
<b>Impact #</b>	<b>Missile Weight</b>	<b>Missile Speed</b>	<b>Damage Observation</b>
1	9.0 lb	28 mph	No penetration, some nails backing out, no cracking
2	9.0 lb	32 mph	No penetration, some nails backing out, no cracking
3	9.0 lb	34 mph	No penetration, some nails backing out, no cracking

4	9.0 lb	36 mph	Cracking of plywood
5	9.0 lb	35 mph	Close to edge - penetration
6	9.0 lb	26 mph	Penetration in Lower LH Corner
7	9.0 lb	24 mph	Hit in middle of panel - No Penetration
8	9.0 lb	22 mph	No Penetration
9	9.0 lb	NS	No Penetration
10	9.0 lb	25 mph	Penetration

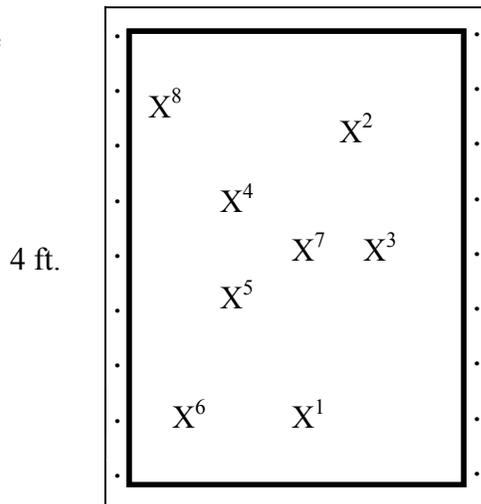
<b>Test Number:</b> Panel 9			
<b>Panel Type:</b> 7/16 Oriented Strand Board - soaked for 24 hrs in water bath			
<b>Panel Layout:</b> 2' x 4' Opening Strong Axis in 4' direction	<b>Nailing Schedule and Location:</b> 12d common 6" along sides of the panel		
<b>Missile Impact:</b> <input type="checkbox"/> None <input checked="" type="checkbox"/> 2x4 <input type="checkbox"/> Clay Tile	<b>Pressure Test:</b> <input type="checkbox"/> None <input type="checkbox"/> Monotonic to Failure ___ psf failure <input type="checkbox"/> Cyclic _____ Design Wind Speed <input type="checkbox"/> _____ Number of Cycles to Failure		
<b>Results of Missile Tests:</b>			
<b>Impact #</b>	<b>Missile Weight</b>	<b>Missile Speed</b>	<b>Damage Observation</b>
1	4.54 lb	27 mph	Perforated panel but missile rebounded
2	4.54 lb	41 mph	Blew right through panel
3	4.54 lb	27 mph	
4	4.54 lb	26 mph	No Penetration or Perforation but dented panel

5	4.54 lb	29 mph	Punctured Panel but missile rejected
6	4.54 lb	30 mph	Perforation
7	4.54 lb	25 mph	No damage – hit middle of panel
8	4.54 lb	26 mph	Perforation along edge of panel but missile did not penetrate
9			
10

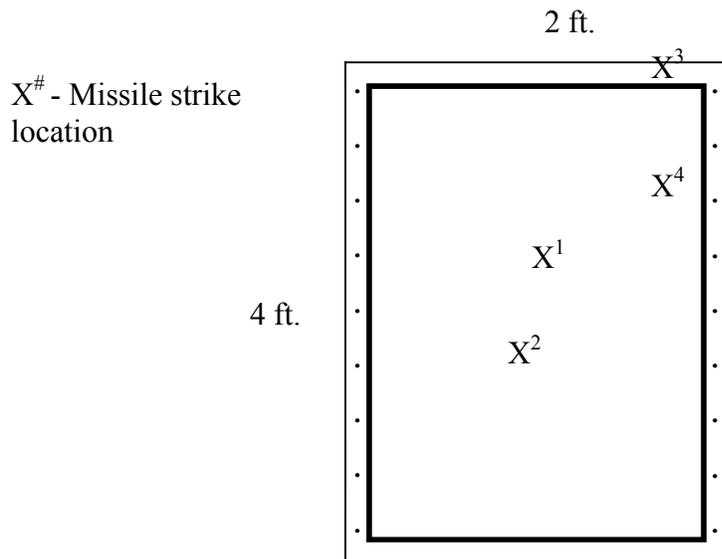
<b>Test Number:</b> Panel 10			
<b>Panel Type:</b> 15/32 Plywood – 4 Ply			
<b>Panel Layout:</b> 2' x 4' Opening Strong Axis in 4' direction	<b>Nailing Schedule and Location:</b> 12d common 6" along sides of the panel		
<b>Missile Impact:</b> <input type="checkbox"/> None <input type="checkbox"/> 2x4 <input checked="" type="checkbox"/> Clay Tile	<b>Pressure Test:</b> <input type="checkbox"/> None <input type="checkbox"/> Monotonic to Failure ___ psf failure <input type="checkbox"/> Cyclic _____ Design Wind Speed <input type="checkbox"/> _____ Number of Cycles to Failure		
<b>Results of Missile Tests:</b>			
<b>Impact #</b>	<b>Missile Weight</b>	<b>Missile Speed</b>	<b>Damage Observation</b>
1	6.68 lb	30 mph	Part of tile broke off in shutter – did not fully penetrate
2	6.67 lb	33 mph	Partial penetration
3	6.62 lb	27 mph	Hit too high
4	6.70 lb	34 mph	Tile punctured shutter and stuck in plywood (hit near edge)

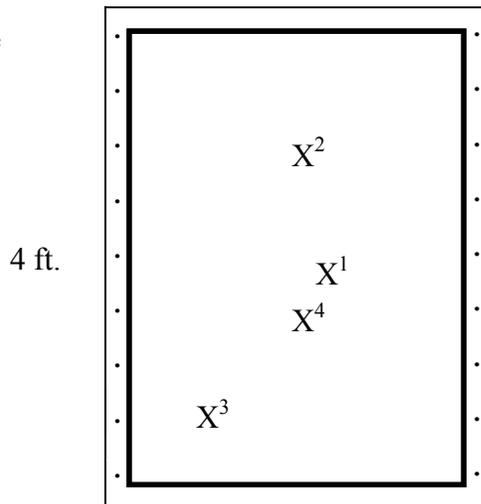
<b>Test Number:</b> Panel 11			
<b>Panel Type:</b> 15/32 Plywood – 3 Ply			
<b>Panel Layout:</b> 2' x 4' Opening Strong Axis in 4' direction	<b>Nailing Schedule and Location:</b> 12d common 6" along sides of the panel		
<b>Missile Impact:</b> <input type="checkbox"/> None <input type="checkbox"/> 2x4 <input checked="" type="checkbox"/> Clay Tile	<b>Pressure Test:</b> <input type="checkbox"/> None <input type="checkbox"/> Monotonic to Failure ___ psf failure <input type="checkbox"/> Cyclic _____ Design Wind Speed <input type="checkbox"/> _____ Number of Cycles to Failure		
<b>Results of Missile Tests:</b>			
<b>Impact #</b>	<b>Missile Weight</b>	<b>Missile Speed</b>	<b>Damage Observation</b>
1	6.74 lb	30 mph	Indented front and cracked back of shutter
2	6.67 lb	33 mph	Partial penetration, cracked large section of panel
3	6.67 lb	34 mph	Cut panel and cracked plywood
4	1.92 lb	34 mph	Partial tile, hit flat – little or no damage

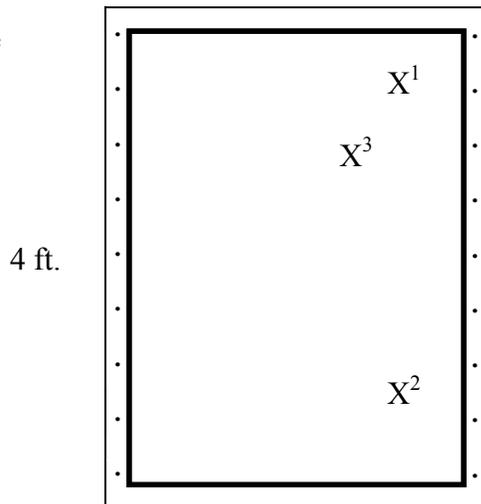
<b>Test Number:</b> Panel 12			
<b>Panel Type:</b> 15/32 Plywood – 4 Ply			
<b>Panel Layout:</b> 2' x 4' Opening Strong Axis in 4' direction	<b>Nailing Schedule and Location:</b> 12d common 6" along sides of the panel		
<b>Missile Impact:</b> <input type="checkbox"/> None <input type="checkbox"/> 2x4 <input checked="" type="checkbox"/> Clay Tile	<b>Pressure Test:</b> <input type="checkbox"/> None <input type="checkbox"/> Monotonic to Failure ___ psf failure <input type="checkbox"/> Cyclic _____ Design Wind Speed <input type="checkbox"/> _____ Number of Cycles to Failure		
<b>Results of Missile Tests:</b>			
<b>Impact #</b>	<b>Missile Weight</b>	<b>Missile Speed</b>	<b>Damage Observation</b>
1	6.76 lb	37 mph	Perforation of shutter, tile bounced back, wood split
2	6.64 lb	34 mph	Punctured shutter some tile stuck in shutter
3	4.3 lb	34 mph	Indented panel surface but no perforation
4			
5			
6			
7			
8

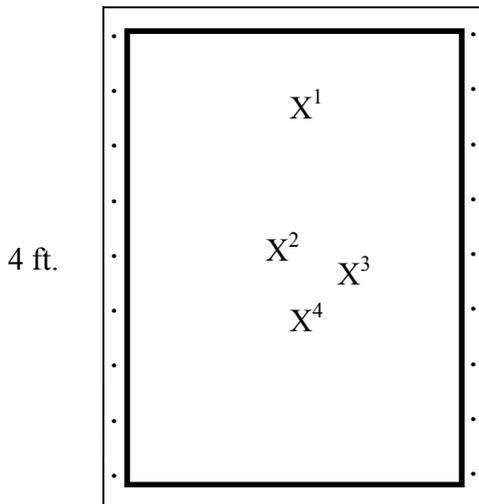
<b>Test Number:</b> Panel 13			
<b>Panel Type:</b> 7/16 Oriented Strand Board			
<b>Panel Layout:</b> 2' x 4' Opening Strong Axis in 4' direction	<b>Nailing Schedule and Location:</b> 12d common 6" along sides of the panel		
<b>Missile Impact:</b> <input type="checkbox"/> None <input type="checkbox"/> 2x4 <input checked="" type="checkbox"/> Clay Tile	<b>Pressure Test:</b> <input type="checkbox"/> None <input type="checkbox"/> Monotonic to Failure ___ psf failure <input type="checkbox"/> Cyclic _____ Design Wind Speed <input type="checkbox"/> _____ Number of Cycles to Failure		
<b>Results of Missile Tests:</b>			
<b>Impact #</b>	<b>Missile Weight</b>	<b>Missile Speed</b>	<b>Damage Observation</b>
1	6.64 lb	30 mph	Shutter penetrated by missile – left a large hole in shutter
2	6.70 lb	~25mph	Rotated as it hit, no visible damage
3	6.74 lb	~25mph	Rotated as it hit, no visible damage
4	6.72 lb	28 mph	Penetration of OSB – Tile stuck in OSB

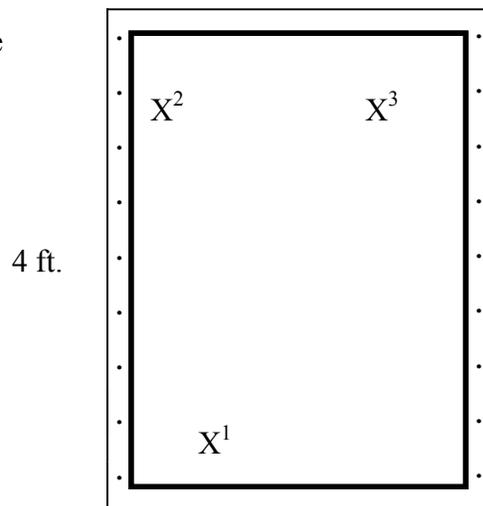
<b>Test Number:</b> Panel 14			
<b>Panel Type:</b> 7/16 Oriented Strand Board			
<b>Panel Layout:</b> 2' x 4' Opening Strong Axis in 4' direction	<b>Nailing Schedule and Location:</b> 12d common 6" along sides of the panel		
<b>Missile Impact:</b> <input type="checkbox"/> None <input type="checkbox"/> 2x4 <input checked="" type="checkbox"/> Clay Tile	<b>Pressure Test:</b> <input type="checkbox"/> None <input type="checkbox"/> Monotonic to Failure ___ psf failure <input type="checkbox"/> Cyclic _____ Design Wind Speed <input type="checkbox"/> _____ Number of Cycles to Failure		
<b>Results of Missile Tests:</b>			
<b>Impact #</b>	<b>Missile Weight</b>	<b>Missile Speed</b>	<b>Damage Observation</b>
1	6.72 lb	27 mph	Penetrated panel knocked big hole in panel
2	6.76 lb	NS	Slight cut in panel
3	6.74 lb	26 mph	Broke panel but tile fell to outside of panel
4			
5			
6			
7			
8			
9			
10

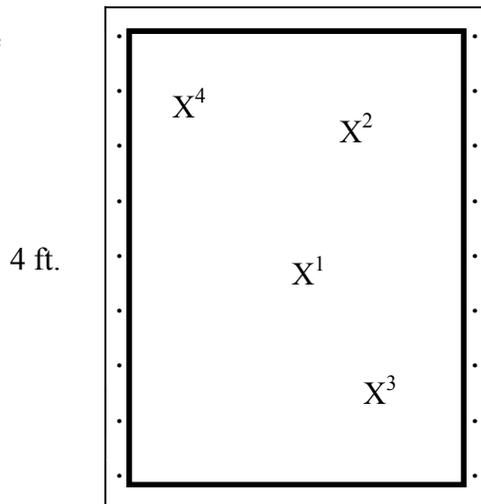
<b>Test Number:</b> Panel 15			
<b>Panel Type:</b> 7/16 Oriented Strand Board			
<b>Panel Layout:</b> 2' x 4' Opening Strong Axis in 4' direction	<b>Nailing Schedule and Location:</b> 12d common 6" along sides of the panel		
<b>Missile Impact:</b> <input type="checkbox"/> None <input type="checkbox"/> 2x4 <input checked="" type="checkbox"/> Clay Tile	<b>Pressure Test:</b> <input type="checkbox"/> None <input type="checkbox"/> Monotonic to Failure ___ psf failure <input type="checkbox"/> Cyclic _____ Design Wind Speed <input type="checkbox"/> _____ Number of Cycles to Failure		
<b>Results of Missile Tests:</b>			
<b>Impact #</b>	<b>Missile Weight</b>	<b>Missile Speed</b>	<b>Damage Observation</b>
1	6.64 lb	25 mph	Penetrated panel
2	6.62 lb	27 mph	Heavy damage – dented panel
3	6.62 lb	28 mph	Threshold penetration
4	6.62 lb	28 mph	Penetration
5			
6			
7			
8			
9			
10

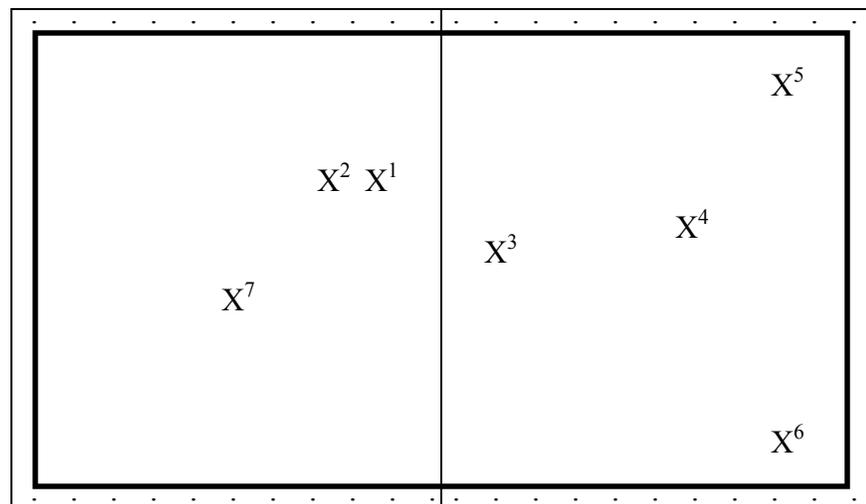
<b>Test Number:</b> Panels 16 and 17			
<b>Panel Type:</b> 15/32 Plywood – 4 Ply; Two 3'-9" by 5'-6" panels			
<b>Panel Layout:</b> 5' x 7' Opening; Two panels with strong axis oriented in 5' direction (2 vertical panels)	<b>Nailing Schedule and Location:</b> 12d common 4" along top and bottom of the panel		
<b>Missile Impact:</b> <input type="checkbox"/> None <input type="checkbox"/> 2x4 <input checked="" type="checkbox"/> Clay Tile	<b>Pressure Test:</b> <input type="checkbox"/> None <input type="checkbox"/> Monotonic to Failure ___ psf failure <input type="checkbox"/> Cyclic _____ Design Wind Speed <input type="checkbox"/> _____ Number of Cycles to Failure		
<b>Results of Missile Tests:</b>			
<b>Impact #</b>	<b>Missile Weight</b>	<b>Missile Speed</b>	<b>Damage Observation</b>
1	6.64 lb	29 mph	Scuff marks on surface of panel
2	6.62 lb	33 mph	Hit on top of first hit, broke plywood but bounced off

3	6.62 lb	35 mph	Cracked plywood but bounced off
4	6.64 lb	NS	Rotating as it hit, no damage
5	6.62 lb	37 mph	Slight rotation as tile hit shutter – indented surface of shutter
6	6.64 lb	41 mph	Cut through surface of shutter, some tile stuck in the shutter
7	6.62 lb	41 mph	Cracking of already damaged plywood
8			
9			
10
