Final Report

Department of Community Affairs  
DCA Contract 03-RC-11-14-00-22-034

# Loss Relativities for FBC Wood Panel Shutters

The purpose of this project is to develop loss relativities for 1 and 2 family residential structures that have openings protected by wood structural panels, as allowed by the Florida Building Code (FBC).

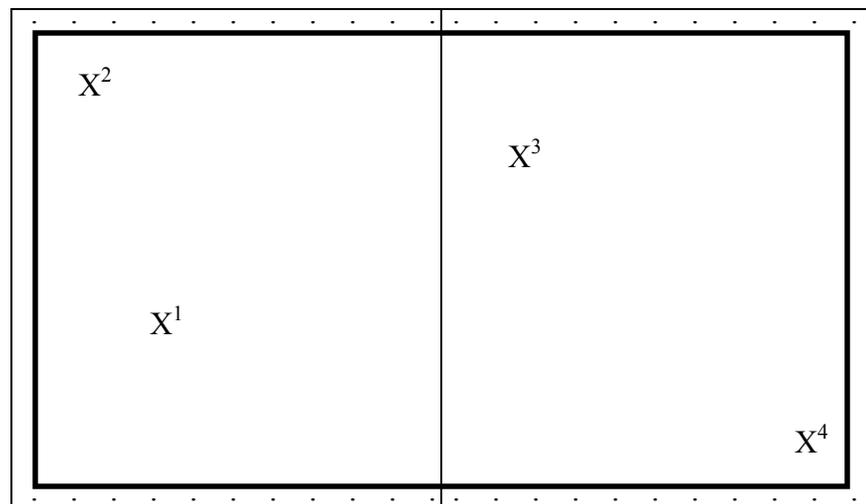
<b>Test Number:</b> Panels 18 and 19			
<b>Panel Type:</b> 7/16 Oriented Strand Board; Two 3'-9" by 5'-6" panels			
<b>Panel Layout:</b> 5' x 7' Opening; Two panels with strong axis oriented in 5' direction (2 vertical panels)	<b>Nailing Schedule and Location:</b> 12d common 4" along top and bottom of the panel		
<b>Missile Impact:</b> <input type="checkbox"/> None <input type="checkbox"/> 2x4 <input checked="" type="checkbox"/> Clay Tile	<b>Pressure Test:</b> <input type="checkbox"/> None <input type="checkbox"/> Monotonic to Failure ___ psf failure <input type="checkbox"/> Cyclic _____ Design Wind Speed <input type="checkbox"/> _____ Number of Cycles to Failure		
<b>Results of Missile Tests:</b>			
<b>Impact #</b>	<b>Missile Weight</b>	<b>Missile Speed</b>	<b>Damage Observation</b>
1	6.62 lb	35 mph	Punched through shutter, some broken tile got past shutter
2	6.58 lb	33 mph	Surface crack, local shearing of OSB

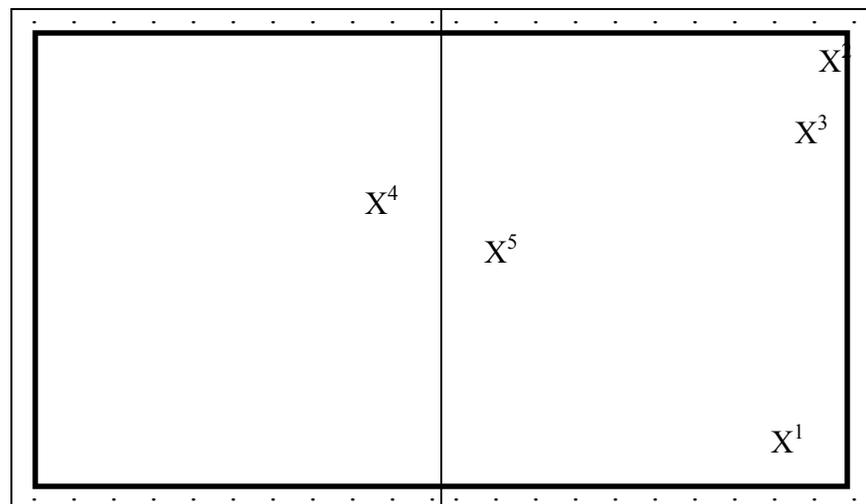
<b>Test Number:</b> Panels 20 and 21			
<b>Panel Type:</b> 15/32 Plywood – 3 Ply; Two 3’-9” by 5’-6” panels			
<b>Panel Layout:</b> 5’ x 7’ Opening; Two panels with strong axis oriented in 5’ direction (2 vertical panels)	<b>Nailing Schedule and Location:</b> 12d common 4” along top and bottom of the panel		
<b>Missile Impact:</b> <input type="checkbox"/> None <input type="checkbox"/> 2x4 <input checked="" type="checkbox"/> Clay Tile	<b>Pressure Test:</b> <input type="checkbox"/> None <input type="checkbox"/> Monotonic to Failure ___ psf failure <input type="checkbox"/> Cyclic _____ Design Wind Speed _____ Number of Cycles to Failure		
<b>Results of Missile Tests:</b>			
<b>Impact #</b>	<b>Missile Weight</b>	<b>Missile Speed</b>	<b>Damage Observation</b>
1	6.58 lb	37 mph	Broke through panel – some tile inside window
2	6.62 lb	37 mph	Hit partially on support at edge of window – partially cut through shutter

3	6.70 lb	35 mph	Cracked panel, split plywood, some debris inside window
4	6.70 lb	40 mph	Cracked interior ply of plywood, panel more flexible
5	6.64 lb	41 mph	Cracked interior and exterior plies
6			
7			
8			
9

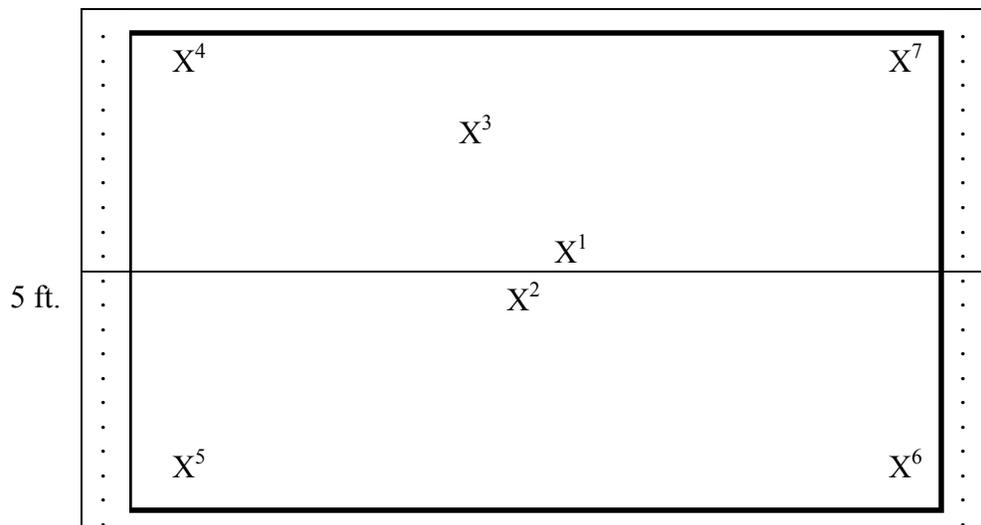
<b>Test Number:</b> Panels 22 and 23			
<b>Panel Type:</b> 7/16 Oriented Strand Board; Two 7'-6" by 2'-9" panels			
<b>Panel Layout:</b> 5' x 7' Opening; Two panels with strong axis oriented in 7' direction (2 horizontal panels)	<b>Nailing Schedule and Location:</b> 12d common 3" along each side of the panel		
<b>Missile Impact:</b> <input type="checkbox"/> None <input type="checkbox"/> 2x4 <input checked="" type="checkbox"/> Clay Tile	<b>Pressure Test:</b> <input type="checkbox"/> None <input type="checkbox"/> Monotonic to Failure ___ psf failure <input type="checkbox"/> Cyclic _____ Design Wind Speed _____ Number of Cycles to Failure		
<b>Results of Missile Tests:</b>			
<b>Impact #</b>	<b>Missile Weight</b>	<b>Missile Speed</b>	<b>Damage Observation</b>
1	6.62 lb	38 mph	Punched hole in shutter
2	6.62 lb	36 mph	Punched right through shutter, partially hit first hole
3	6.60 lb	35 mph	Punched right through shutter

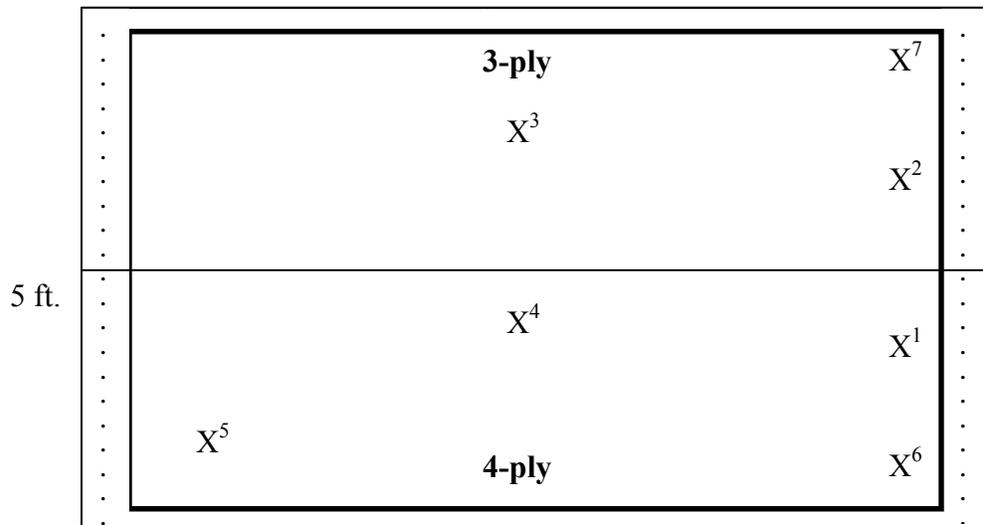
<b>Test Number:</b> Panels 24 and 25			
<b>Panel Type:</b> 15/32 Plywood; Two 7'-6" by 2'-9" panels; Top panel is 3-ply and Bottom panel is 4-ply			
<b>Panel Layout:</b> 5' x 7' Opening; Two panels with strong axis oriented in 7' direction (2 horizontal panels)		<b>Nailing Schedule and Location:</b> 12d common 3" along each side of the panel	
<b>Missile Impact:</b> <input type="checkbox"/> None <input type="checkbox"/> 2x4 <input checked="" type="checkbox"/> Clay Tile		<b>Pressure Test:</b> <input type="checkbox"/> None <input type="checkbox"/> Monotonic to Failure ___ psf failure <input type="checkbox"/> Cyclic _____ Design Wind Speed _____ Number of Cycles to Failure	
<b>Results of Missile Tests:</b>			
Impact #	Missile Weight	Missile Speed	Damage Observation
1	6.68 lb	46 mph	Punched hole in 4 ply panel
2	6.68 lb	43 mph	Punched hole in 3 ply panel
3	6.62 lb	44 mph	Cracked panel from top to near middle of panel

4	6.64 lb	45 mph	Triple crack in plywood
5	6.64 lb	41 mph	Cracked panel but rejected missile
6			
7			
8			
9			
10

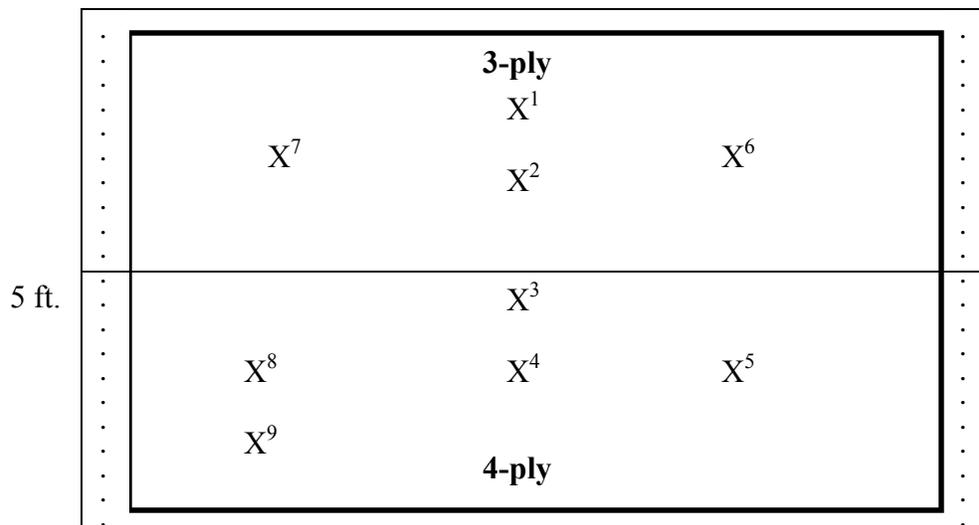
<b>Test Number:</b> Panels 26 and 27			
<b>Panel Type:</b> 15/32 Plywood; Two 7'-6" by 2'-9" panels; Top panel is 3-ply and Bottom panel is 4-ply			
<b>Panel Layout:</b> 5' x 7' Opening; Two panels with strong axis oriented in 7' direction (2 horizontal panels)	<b>Nailing Schedule and Location:</b> 12d common 3" along each side of the panel		
<b>Missile Impact:</b> <input type="checkbox"/> None <input checked="" type="checkbox"/> 2x4 <input type="checkbox"/> Clay Tile	<b>Pressure Test:</b> <input type="checkbox"/> None <input type="checkbox"/> Monotonic to Failure ___ psf failure <input type="checkbox"/> Cyclic _____ Design Wind Speed <input type="checkbox"/> _____ Number of Cycles to Failure		
<b>Results of Missile Tests:</b>			
<b>Impact #</b>	<b>Missile Weight</b>	<b>Missile Speed</b>	<b>Damage Observation</b>
1	4.54 lb	44 mph	Cracked inside ply of 3-ply panel
2	4.54 lb	46 mph	Penetration
3	4.54 lb	NS	Approx 46 mph, penetrated

4	4.54 lb	43 mph	Penetrated panel
5	4.54 lb	40 mph	Punctured panel
6	4.54 lb	39 mph	Punctured panel
7	4.54 lb	38 mph	Cracked panel but bounced off
8	4.54 lb	38 mph	Penetrated
9	4.54 lb	36 mph	Penetrated
10	4.54 lb	34 mph	Cracked back of panel but bounced off

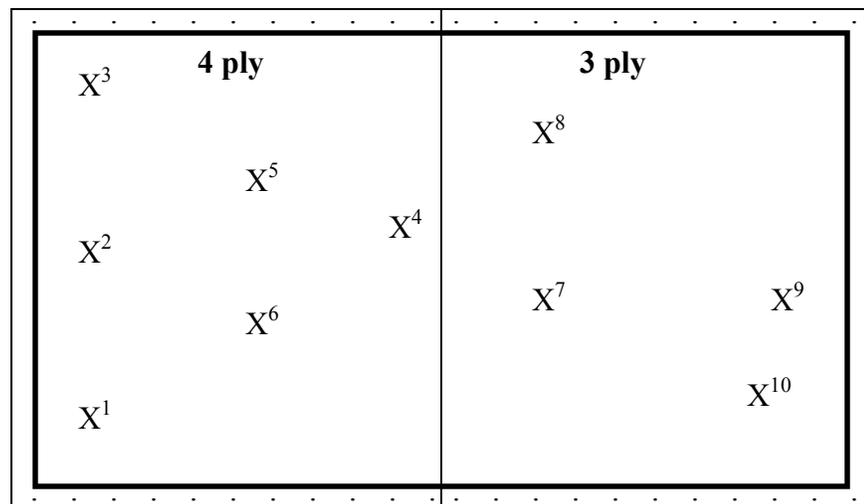
<b>Test Number:</b> Panels 28 and 29			
<b>Panel Type:</b> 15/32 Plywood; Two 3'-9" by 5'-6" panels; 4-ply on left and 3-ply on right			
<b>Panel Layout:</b> 5' x 7' Opening; Two panels with strong axis oriented in 5' direction (2 vertical panels)	<b>Nailing Schedule and Location:</b> 12d common 4" along top and bottom of the panel		
<b>Missile Impact:</b> <input type="checkbox"/> None <input checked="" type="checkbox"/> 2x4 <input type="checkbox"/> Clay Tile	<b>Pressure Test:</b> <input type="checkbox"/> None <input type="checkbox"/> Monotonic to Failure ___ psf failure <input type="checkbox"/> Cyclic _____ Design Wind Speed <input type="checkbox"/> _____ Number of Cycles to Failure		
<b>Results of Missile Tests:</b>			
<b>Impact #</b>	<b>Missile Weight</b>	<b>Missile Speed</b>	<b>Damage Observation</b>
1	4.54 lb	34 mph	Puncture of 4-ply panel
2	4.54 lb	32 mph	Punctured panel
3	4.54 lb	30 mph	Cracked surface and back plys of panel

4	4.54 lb	30 mph	Cracked panel
5	4.54 lb	34 mph	Penetrated panel
6	4.54 lb	34 mph	Penetrated panel
7	4.54 lb	33 mph	Indented panel, cracked interior ply
8	4.54 lb	37 mph	Cracked panel
9	4.54 lb	36 mph	Penetrated panel
10	4.54 lb	33 mph	Indented surfaced and cracked panel

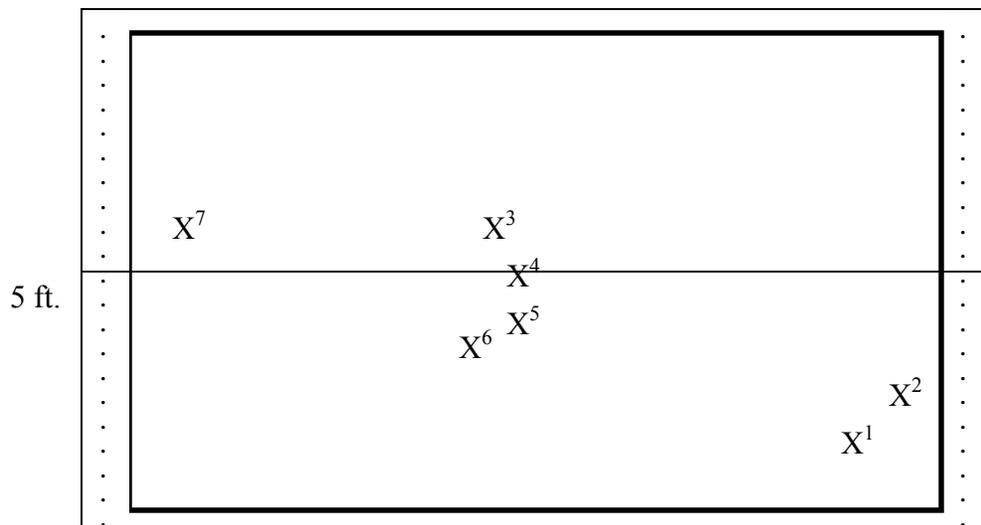
<b>Test Number:</b> Panels 30 and 31			
<b>Panel Type:</b> 7/16 Oriented Strand Board; Two 7'-6" by 2'-9" panels			
<b>Panel Layout:</b> 5' x 7' Opening; Two panels with strong axis oriented in 7' direction (2 horizontal panels)		<b>Nailing Schedule and Location:</b> 12d common 3" along each side of the panel	
<b>Missile Impact:</b> <input type="checkbox"/> None <input checked="" type="checkbox"/> 2x4 <input type="checkbox"/> Clay Tile		<b>Pressure Test:</b> <input type="checkbox"/> None <input type="checkbox"/> Monotonic to Failure ___ psf failure <input type="checkbox"/> Cyclic _____ Design Wind Speed <input type="checkbox"/> _____ Number of Cycles to Failure	
<b>Results of Missile Tests:</b>			
<b>Impact #</b>	<b>Missile Weight</b>	<b>Missile Speed</b>	<b>Damage Observation</b>
1	4.54 lb	25 mph	Penetration
2	4.54 lb	21 mph	Penetration
3	4.54 lb	23 mph	Cracked back, partial break but did not penetrate

4	4.56 lb	25 mph	Local cracking, impacted on seam between panels
5	4.56 lb	25 mph	Indented panel but did not penetrate
6	4.56 lb	29 mph	Broke panel at previously damaged area
7	4.56 lb	22 mph	Penetration
8			
9			
10

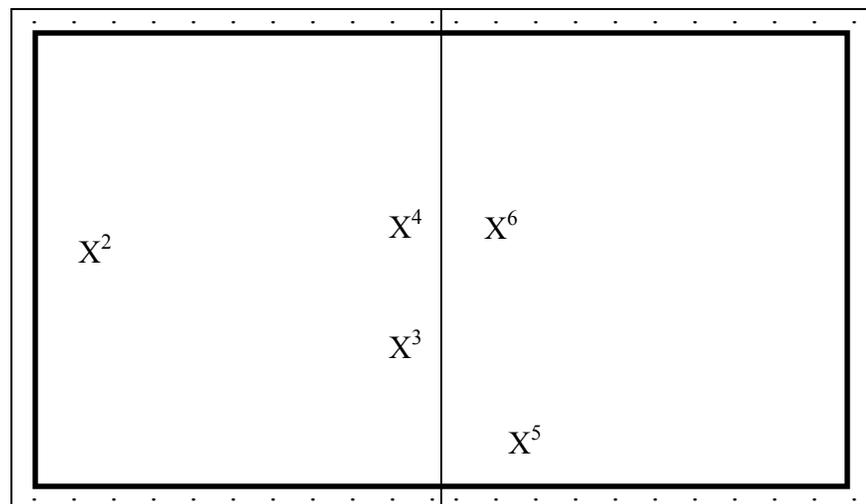
<b>Test Number:</b> Panels 32 and 33			
<b>Panel Type:</b> 7/16 Oriented Strand Board; Two 3'-9" by 5'-6" panels			
<b>Panel Layout:</b> 5' x 7' Opening; Two panels with strong axis oriented in 5' direction (2 vertical panels)	<b>Nailing Schedule and Location:</b> 12d common 4" along top and bottom of the panel		
<b>Missile Impact:</b> <input type="checkbox"/> None <input checked="" type="checkbox"/> 2x4 <input type="checkbox"/> Clay Tile	<b>Pressure Test:</b> <input type="checkbox"/> None <input type="checkbox"/> Monotonic to Failure ___ psf failure <input type="checkbox"/> Cyclic _____ Design Wind Speed <input type="checkbox"/> _____ Number of Cycles to Failure		
<b>Results of Missile Tests:</b>			
<b>Impact #</b>	<b>Missile Weight</b>	<b>Missile Speed</b>	<b>Damage Observation</b>
1	4.56 lb	18 mph	Missed low
2	4.56 lb	21 mph	Indented OSB but did not penetrate
3	4.56 lb	24 mph	Scuffed up surface

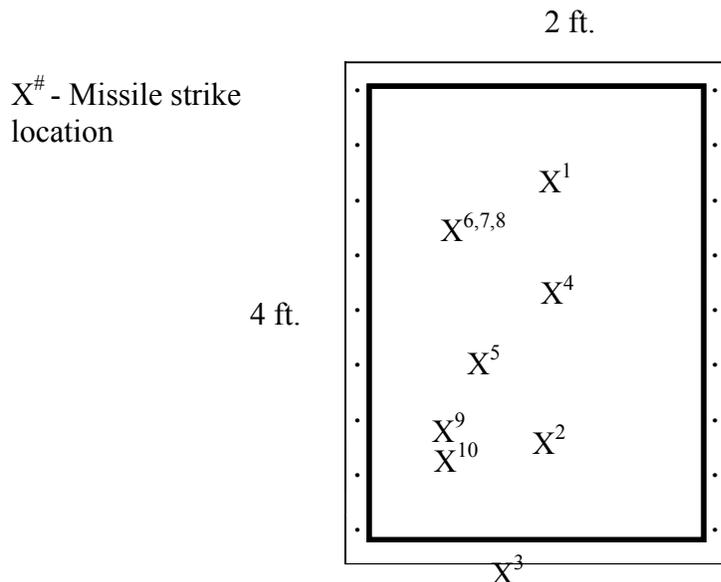
<b>Test Number:</b> Panel 34			
<b>Panel Type:</b> 7/16 Oriented Strand Board – alternating 24 hr. wet and dry cycles over a two week period			
<b>Panel Layout:</b> 2' x 4' Opening Strong Axis in 4' direction	<b>Nailing Schedule and Location:</b> 12d common 6" along sides of the panel		
<b>Missile Impact:</b> <input type="checkbox"/> None <input checked="" type="checkbox"/> 2x4 <input type="checkbox"/> Clay Tile	<b>Pressure Test:</b> <input type="checkbox"/> None <input type="checkbox"/> Monotonic to Failure ___ psf failure <input type="checkbox"/> Cyclic _____ Design Wind Speed <input type="checkbox"/> _____ Number of Cycles to Failure		
<b>Results of Missile Tests:</b>			
<b>Impact #</b>	<b>Missile Weight</b>	<b>Missile Speed</b>	<b>Damage Observation</b>
1	4.02 lb	41 mph	Penetration
2	4.02 lb	32 mph	Penetration
3	4.02 lb	21 mph	Missed panel
4	4.02 lb	28 mph	Penetration
5	4.02 lb	25 mph	Dented panel

6	4.02 lb	25 mph	Dent – Full imprint of 2x4
7	4.02 lb	26 mph	Hit same spot as #6
8	4.02 lb	27 mph	Hit same spot as #6
9	4.02 lb	25 mph	Penetration
10	4.02 lb	23 mph	Slightly below #9, penetration

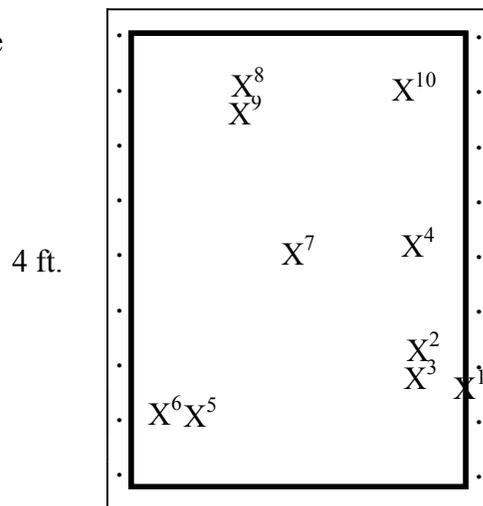
<b>Test Number:</b> Panel 35			
<b>Panel Type:</b> 7/16 Oriented Strand Board - alternating 24 hr. wet and dry cycles over a two week period			
<b>Panel Layout:</b> 2' x 4' Opening Strong Axis in 4' direction	<b>Nailing Schedule and Location:</b> 12d common 6" along sides of the panel		
<b>Missile Impact:</b> <input type="checkbox"/> None <input checked="" type="checkbox"/> 2x4 <input type="checkbox"/> Clay Tile	<b>Pressure Test:</b> <input type="checkbox"/> None <input type="checkbox"/> Monotonic to Failure ___ psf failure <input type="checkbox"/> Cyclic _____ Design Wind Speed <input type="checkbox"/> _____ Number of Cycles to Failure		
<b>Results of Missile Tests:</b>			
<b>Impact #</b>	<b>Missile Weight</b>	<b>Missile Speed</b>	<b>Damage Observation</b>
1	4.02 lb	25 mph	Edge
2	4.02 lb	23 mph	Small Dent
3	4.02 lb	25 mph	Penetration
4	4.02 lb	24 mph	Dent
5	4.02 lb	25 mph	Dent
6	4.02 lb	25 mph	Dent

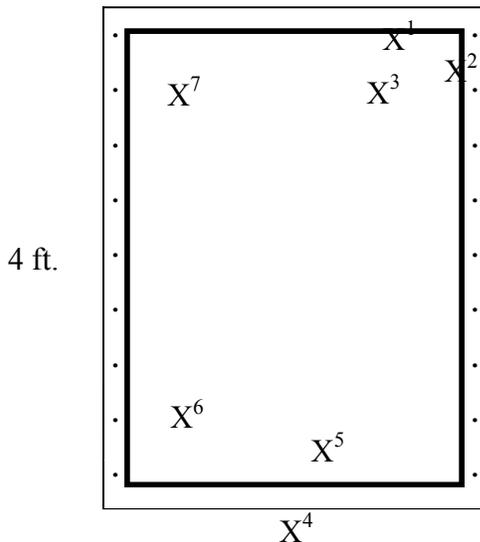
<b>Test Number:</b> Panel 36			
<b>Panel Type:</b> 15/32 Plywood 3-ply - alternating 24 hr. wet and dry cycles over a two week period			
<b>Panel Layout:</b> 2' x 4' Opening Strong Axis in 4' direction	<b>Nailing Schedule and Location:</b> 12d common 6" along sides of the panel		
<b>Missile Impact:</b> <input type="checkbox"/> None <input checked="" type="checkbox"/> 2x4 <input type="checkbox"/> Clay Tile	<b>Pressure Test:</b> <input type="checkbox"/> None <input type="checkbox"/> Monotonic to Failure ___ psf failure <input type="checkbox"/> Cyclic _____ Design Wind Speed <input type="checkbox"/> _____ Number of Cycles to Failure		
<b>Results of Missile Tests:</b>			
<b>Impact #</b>	<b>Missile Weight</b>	<b>Missile Speed</b>	<b>Damage Observation</b>
1	4.02 lb	30 mph	None
2	4.02 lb	35 mph	None
3	4.02 lb	33 mph	Light cracking of back
4	4.02 lb	28 mph	Miss
5	4.02 lb	36 mph	Cracking in back
6	4.02 lb	39 mph	Dent

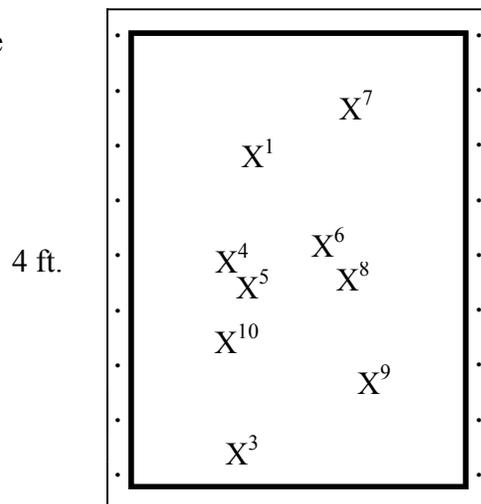
<b>Test Number:</b> Panel 37			
<b>Panel Type:</b> 15/32 Plywood 3-ply - alternating 24 hr. wet and dry cycles over a two week period			
<b>Panel Layout:</b> 2' x 4' Opening Strong Axis in 4' direction	<b>Nailing Schedule and Location:</b> 12d common 6" along sides of the panel		
<b>Missile Impact:</b> <input type="checkbox"/> None <input checked="" type="checkbox"/> 2x4 <input type="checkbox"/> Clay Tile	<b>Pressure Test:</b> <input type="checkbox"/> None <input type="checkbox"/> Monotonic to Failure ___ psf failure <input type="checkbox"/> Cyclic _____ Design Wind Speed <input type="checkbox"/> _____ Number of Cycles to Failure		
<b>Results of Missile Tests:</b>			
<b>Impact #</b>	<b>Missile Weight</b>	<b>Missile Speed</b>	<b>Damage Observation</b>
1	4.02 lb	36 mph	Light cracking in back
2	4.00 lb	25 mph	Miss
3	4.00 lb	25 mph	None
4	4.00 lb	34 mph	Light cracking in back
5	4.00 lb	38 mph	Penetration

6	4.00 lb	37 mph	Moderate cracking in back
7	4.00 lb	39 mph	Penetration
8	4.00 lb	38 mph	Light cracking in back
9	4.00 lb	38 mph	Cracking in back
10	4.00 lb	38 mph	None

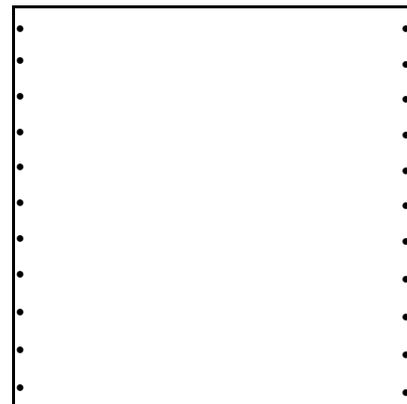
Shutter Description		
	<b>Test Number</b>	Panel 4 - No Missile Shots
	<b>Panel Type</b>	4 ply 3'x5' Plywood
	<b>Panel Size</b>	42"x66"
	<b>Rough Opening Size</b>	36"x60"
	<b>Test Completion Date</b>	5-May-03
	<b>Nail</b>	
	Type	12-D Commons
	Length	3.25"
	Embed Depth	1.75"
	Spacing	6"
	Edge Distance	2.25"
	Location	Left and right sides
	<b>Missile Impact</b>	
	<b>Missile</b>	None
	<b>Pressures</b>	
	<b>Cycles</b>	Pressures for a Basic Wind Speed of 150 mph, Partially Enclosed Design, Exposure C, Wall Zone 5
	Max Positive	75 psf
	Max Negative	94 psf
	Status	Passed
	<b>Static</b>	
	Status	Sustained 154 psf Failed at 209 psf in floor mounted chamber
	<b>Notes</b>	
	<b>Notes</b>	Nails backed out about 1/8" to 1/4"

Number of Cycles	Pressure	
3500	+37.5 psf	Load 1
300	+45.0 psf	Load 2
600	+60.0 psf	Load 3
100	+75.0 psf	Load 4
50	-94.0 psf	Load 5
1050	-75.2 psf	Load 6
50	-56.4 psf	Load 7
3350	-47.0 psf	Load 8

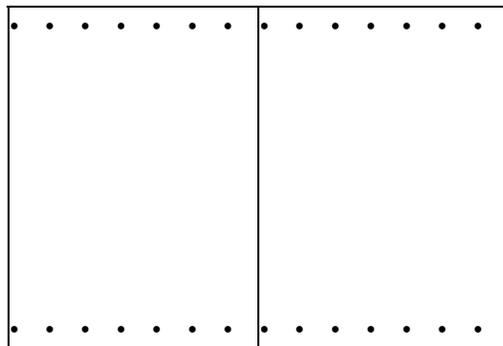
## Plywood Hurricane Shutter Testing

Shutter Description		
	<b>Test Number</b>	Large Panel 1 - No Missile Shots
	<b>Panel Type</b>	4-Ply Plywood
	<b>Panel Size</b>	2 @ 66"x45" vertically spanning opening
	<b>Rough Opening Size</b>	60"x84"
	<b>Test Completion Date</b>	27-May-03
	<b>Nail</b>	
	Type	12-D Commons
	Length	3.25"
	Embed Depth	1.75"
	Spacing	4"
	Edge Distance	2.25"
	Location	Top and Bottom Edges
	<b>Missile Impact</b>	
	<b>None</b>	
	<b>Pressures</b>	
	<b>Cycles</b>	Pressures for a Basic Wind Speed of 130 mph, Enclosed Design, Exposure C, Wall Zone 5
	Max Positive	43 psf
	Max Negative	57 psf
	Status	Passed
	<b>Cycles</b>	Pressures for a Basic Wind Speed of 150 mph, Enclosed Design, Exposure C, Wall Zone 5
	Max Positive	56 psf
	Max Negative	77 psf
	Status	Passed
	<b>Notes</b>	
	<b>Notes</b>	None

Number of Cycles	Pressure (150 mph)	
3500	+28.0 psf	Load 1
300	+33.6 psf	Load 2
600	+44.8 psf	Load 3
100	+56.0 psf	Load 4
50	-75.6 psf	Load 5
1050	-60.5 psf	Load 6
50	-45.4 psf	Load 7
3350	-37.8 psf	Load 8
